Techniques for Testing, Analyzing and Rehabilitation of Terra-Cotta

Sven E. THOMASEN

Consultant
Wiss, Janney, Elstner Assoc.
Emeryville, CA, USA

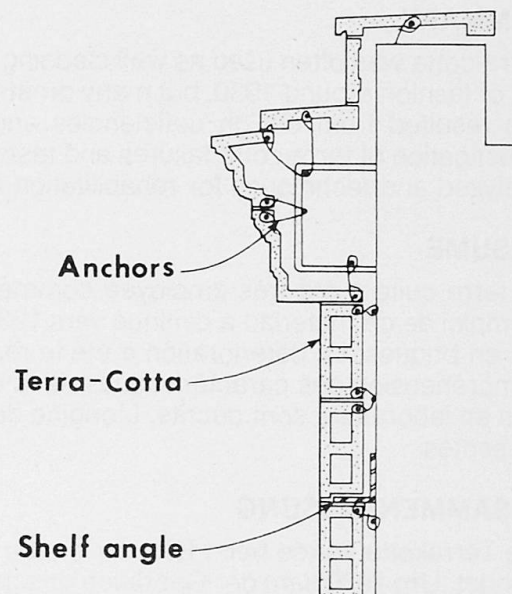
The typical terra-cotta cladding material is about 10 cm thick and from 1000 to 2000 cm² in surface area. The blocks were fabricated by hand pressing the clay into wood forms. The back is open with internal webbing to stiffen the block. The glaze, an aqueous solution of metal salts, was sprayed or brushed on the unfired clay. It was fired to cone 4 to 5 (about 1130°C), resulting in good glaze hardness and high clay strength. The blocks were supported vertically at each floor level by shelf angles. Z-shaped steel straps were fastened into slots in each block and anchored the terra-cotta horizontally to the back-up walls of masonry or concrete. Ornamental units generally had multiple anchors, as seen in Figure 1.

Fig. 1: Terra-Cotta Anchors

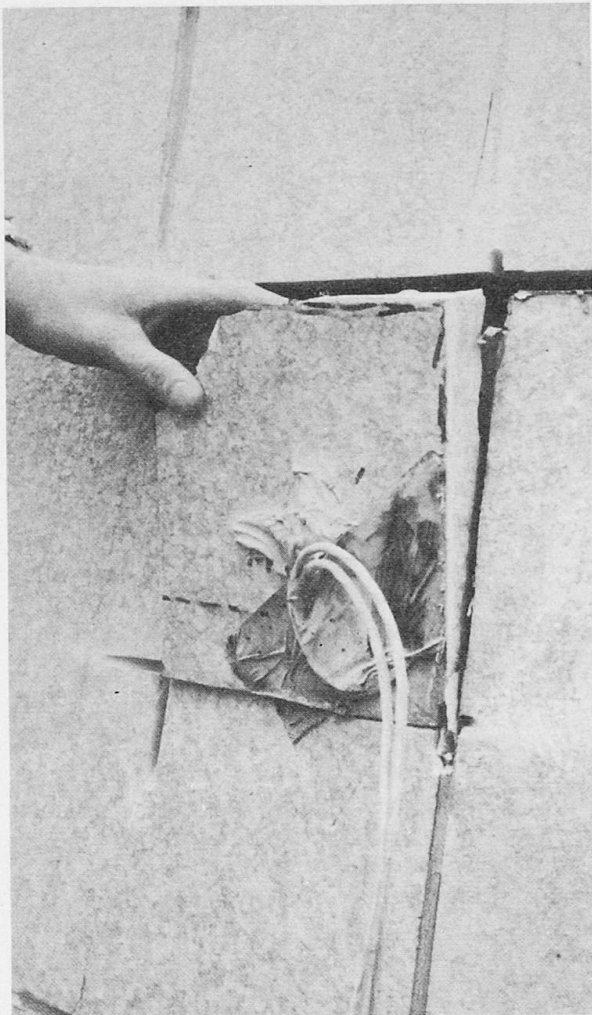
Electrical resistance strain gages are attached to the terra-cotta surface and the gages are read. Then the terra-cotta block, with the gages attached, is cut loose from the wall and the gages are read again, as seen in Figure 6. The change in gage reading is a measure of the strain in the block. The stress in the block is found by multiplying the measured strain difference by the modulus of elasticity, as determined by laboratory tests.

Fig. 6: Terra-cotta block, with strain gages attached, is cut loose.
