Repair and Strengthening of Reinforced Concrete Buildings

In 1978, a severe earthquake shook the Peninsula Izu located 120 km southwest of Tokyo, Japan. Several R/C school buildings were damaged. This paper presents the damage, the method of repair and strengthening, and the seismic capacity of the pre- and post-strengthened buildings.

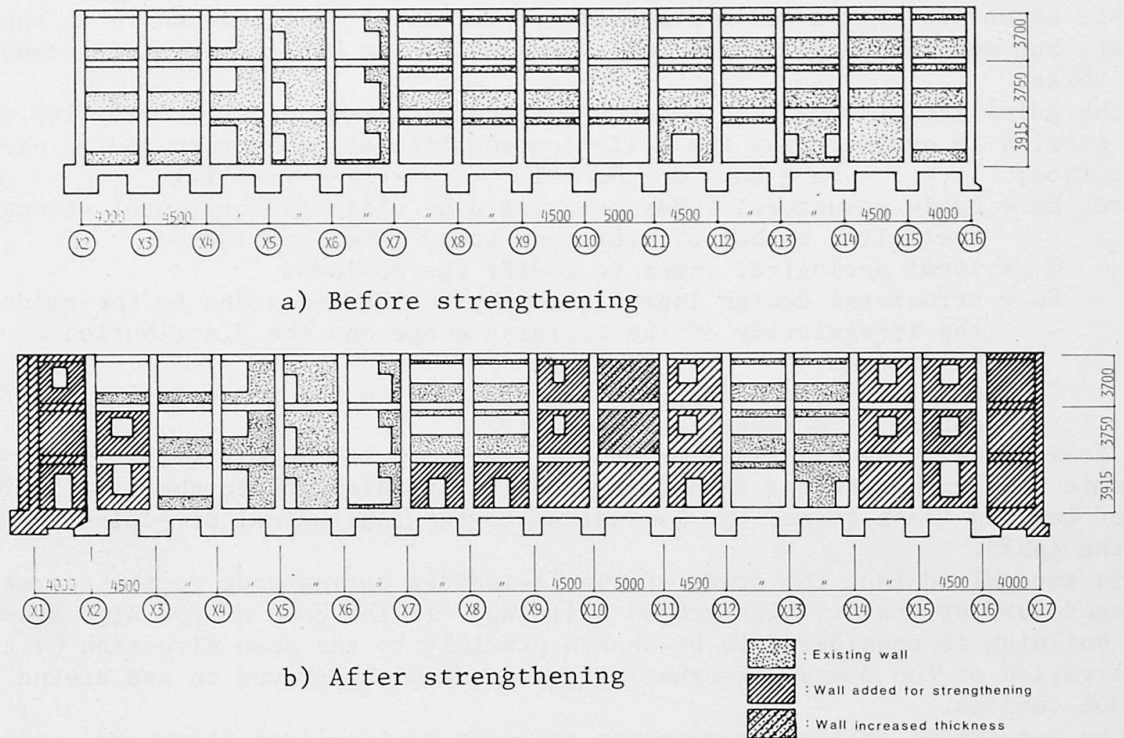
Fig. 8 Frame #Y3 of Atagawa Junior High School

Atagawa junior high school building was one of the damaged buildings. A number of cracks were seen in columns, beams and walls. Both ends of the building were sunk several centimeters. By the excavation of ground, it was found that the footing beams at the west end were failed in shear. Seismic performance of other school buildings were quite well, while hair cracks in the structures, and damage to the non-structural elements were found.
