# Repair of damaged floor slabs

Zeitschrift: **IABSE reports = Rapports AIPC = IVBH Berichte**

## Repair of Damaged Floor Slabs

### Yoichi HIGASHI

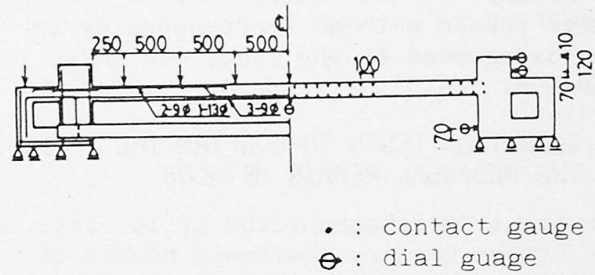
Fig.7 Specimen of short-term loading tests

Each specimen was loaded by many oil jacks as shown Fig.7 until the residual deflection reached the values shown in Table 2, and was unloaded after cracks occured. And the specimens were reloaded

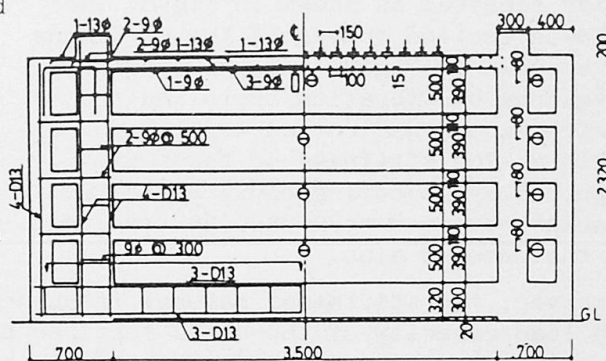
Fig.10 Specimens of long-term loading tests

8 one-way slab specimens of similar section and arrangement as shown in Fig.10 were uniformly loaded steel plates until the residual deflection reached the values shown in Table 3, and they were unloaded after cracks occurred. After repair shown in Fig.8, the specimens were loaded under long-term live load for design ( $W_{LL} = 180 \text{ kg/cm}^2$ ).
