Vibration Fatigue of Steel Bridges of the Bullet Train System

Kenji SAKAMOTO

Chitoshi MIKI

Fatigue cracks caused by out-of-plane vibration were observed in steel bridges of the Tokaido Shinkansen. Crack growth behaviour, measured cyclic stresses, evaluation of fatigue damage, and retrofitting methods are described.

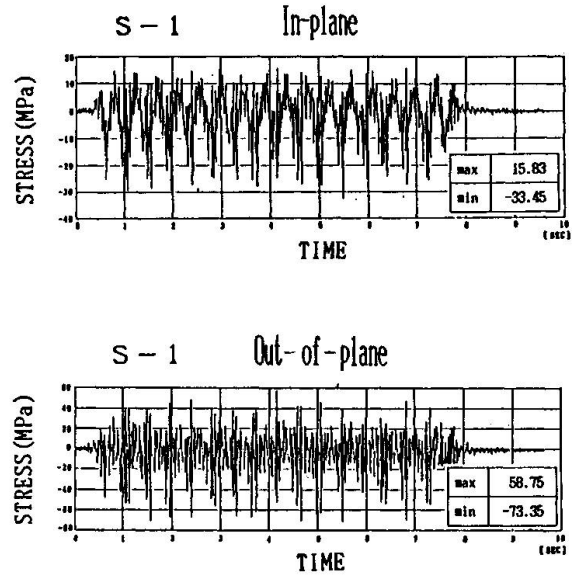
Fig.8 Stress component in In-plane and Out-of-plane of web

Stresses in S-1 is the largest measured value in this structure and its stress waveform exhibits a resonating behavior. However, S-2, the stress waveform of a low-speed train ($v=178$ km/h) does not produce as large stress as S-1 ($v=203$ km/h). Therefore, horizontal vibration of the lower flange was induced only by the passage of high speed trains. In order to examine this resonating behavior, a stress was separated into the in-plane component and the out-of-plane component as shown in Fig.8. Its results indicate that the stress at the lower end of the stiffener without sway bracing detail is mainly caused by out-of-plane distortion of the web plate. From this, it seems possible to say that the source of a predominating stress which occurs at the lower end of a stiffener is horizontal vibrations of the lower flange.

As a countermeasure against these fatigue cracks, it is most effective to stop local horizontal vibrations of lower flange which cause fatigue cracks. In some truss bridge stringers, fatigue cracks were removed by applying of arc air gouging and rewelded and then an additional plates were installed by high-strength bolts (Fig. 10). In some cases a sway bracing was also added. Another possible measure is to increase the fatigue strength of the detail. As it is costly to add plates to a slight fatigue crack, it was necessary to consider an economic method for raising fatigue strength. It is advisable to improve the fatigue strength of the toe of a fillet weld and prevent occurrence of additional crack in a part where occurrence of a fatigue crack is not confirmed as a preventive measure. Application of TIG (Tungsten Inert Gas) arc remelting has considered as an effective and economic method for repairing a fatigue crack at the toe of a fillet weld and improving fatigue strength.
