# Fatigue crack detection and repair of steel bridge structures

Autor(en): **Fisher, John W. / Menzemer, Craig C. / Yen, Ben T.**

Zeitschrift: **IABSE reports = Rapports AIPC = IVBH Berichte**

## Fatigue Crack Detection and Repair of Steel Bridge Structures

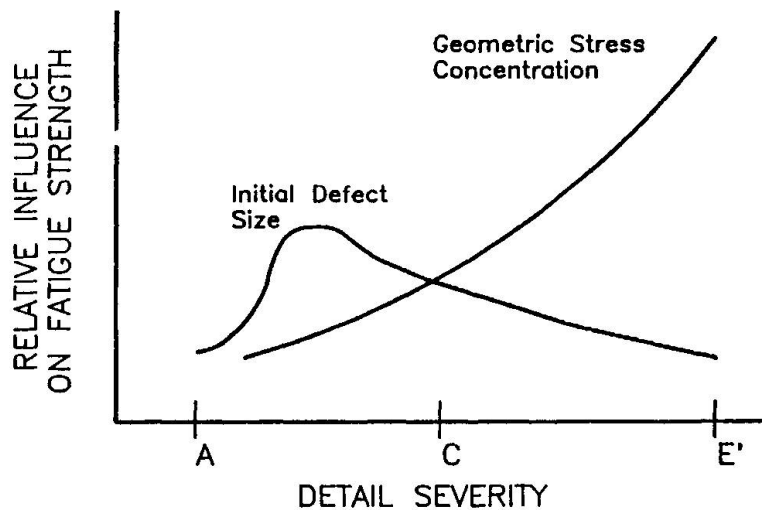
Fig. 1 Relationship Between Fatigue Strength, Detail Type and Defects

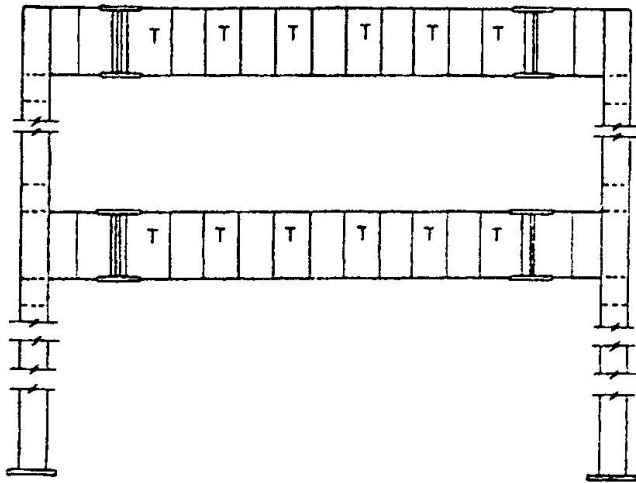
Fig. 2 Typical Bent Elevation

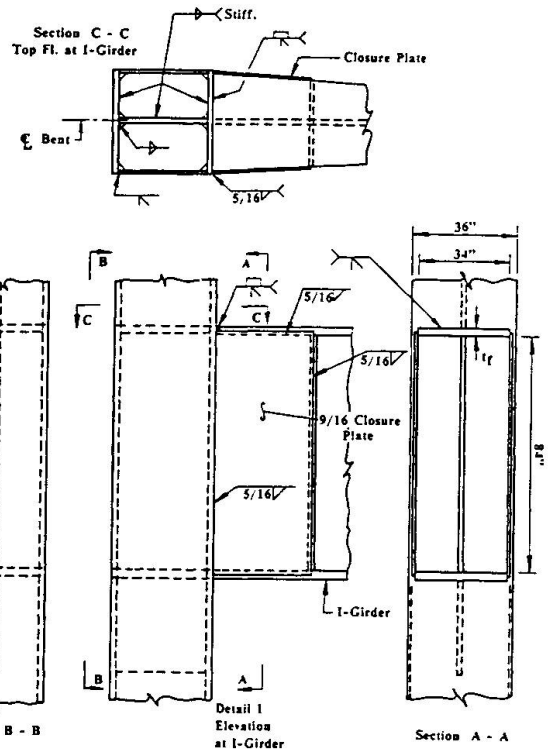
to column connections contain closure plates fillet welded to the edges of the I section and column flanges (Fig. 3). Webs of the I beams are groove welded to the columns while beam flanges (both box and I) and box beam webs of the lower portion of the bents are connected via full penetration groove welds with back-up bars (Fig. 4).

Fig. 3 Representative I-Beam to Column Connection

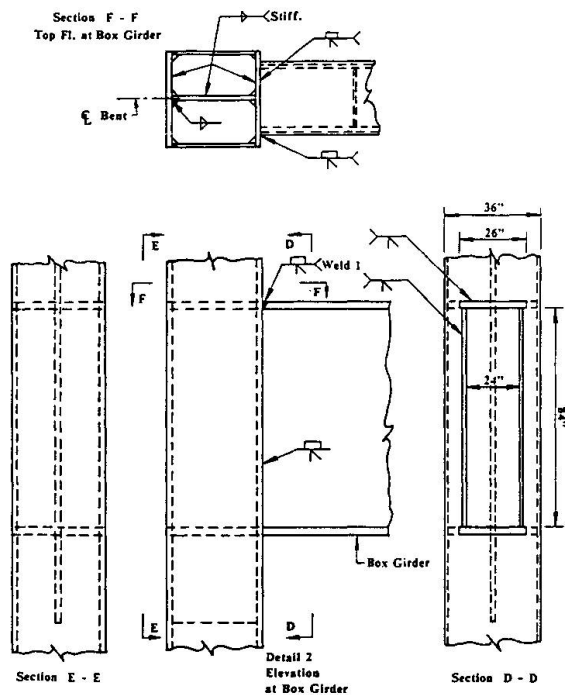
Fig. 4 Representative Box Beam to Column Connection

Beam flanges of the upper portion of the bent are continuous into the column. Cope openings in the box beam webs at the beam column connection points are covered with small plates which are fillet welded to the box beam webs [2].

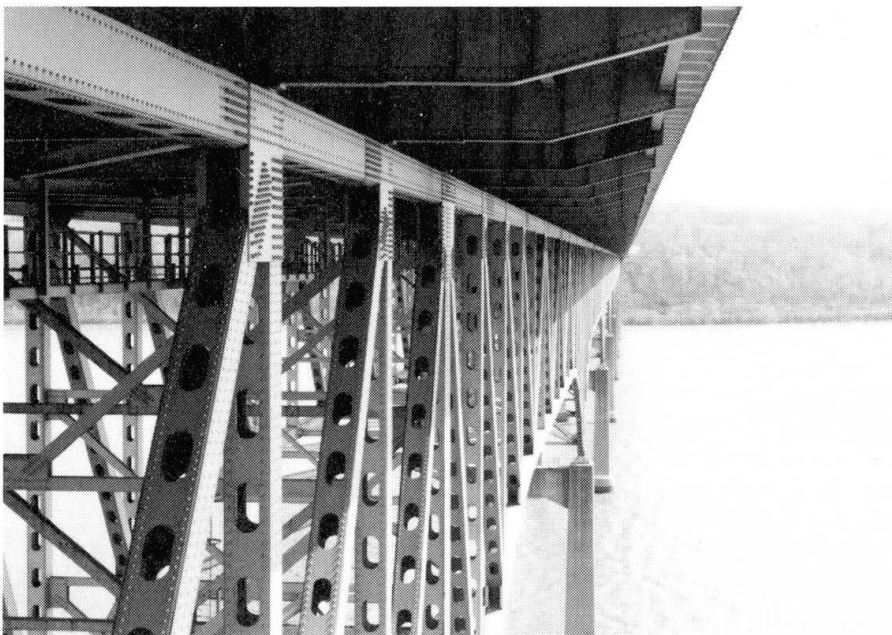
I-95 crosses the Susquehanna River in Maryland. The structure is a multiple span deck truss bridge whose members are either built-up riveted construction or rolled structural shapes. Transverse floorbeams and longitudinal stringers of the floor system are composite with the reinforced concrete deck. All of the floorbeams are supported by the top chord of the main deck trusses (Fig. 12). Suspended truss spans contain pin and hanger assemblies which consist of riveted box sections [2].

Fig. 12 Truss System of the Susquehanna River Bridge
