Autor(en): **Nascè, Vittorio / Pistone, Giuseppe / Roccati, Roberto**

Zeitschrift: **IABSE reports = Rapports AIPC = IVBH Berichte**

Band (Jahr): **70 (1993)**

Investigation of the Roman Aqueduct Structure of Acqui Terme

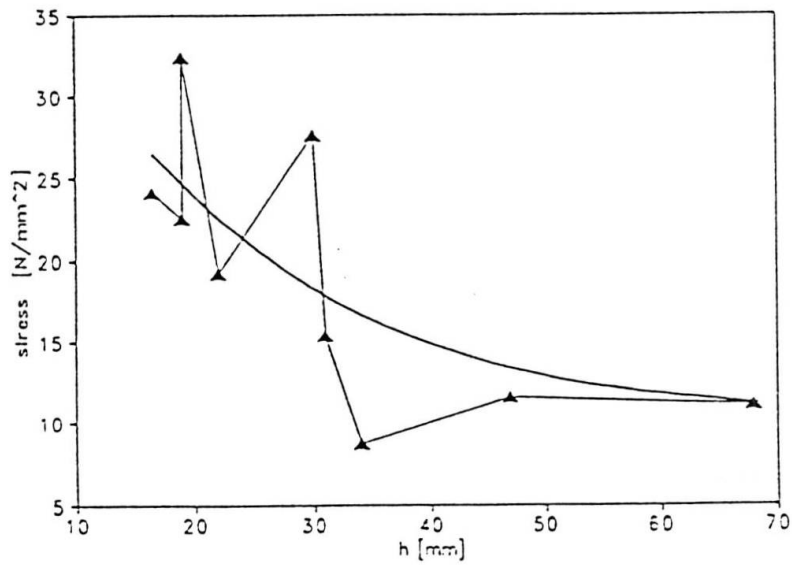
Fig. 1 - Strength as a function of the specimen height.

In the mortar, compressive strength and the elastic modulus were determined on cylinders of different heights: strength was seen to decrease with increasing specimen height (fig. 1), this being an aspect of special interest in the case being considered, on account of the sizeable discontinuities present in the mortar beds of the inner masonry, in terms of both thickness and area.

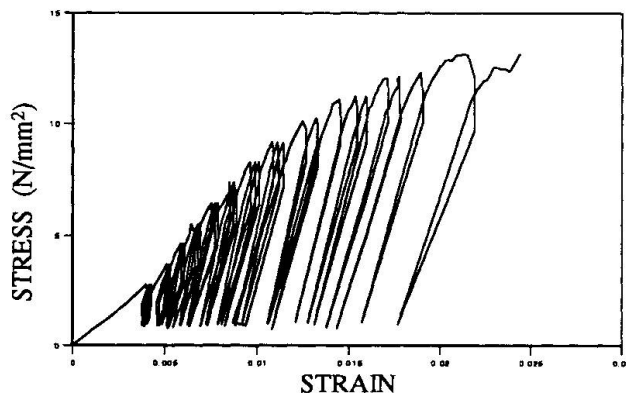
Fig. 2 - Stress-strain curve of strain gauge 7 - specimen 2.

In specimen No. 2 the compression and bending effects were much smaller, on account of a more regular composition (fig. 2), and failure occurred under a load of 1420 KN (13.1 N/mm^2).

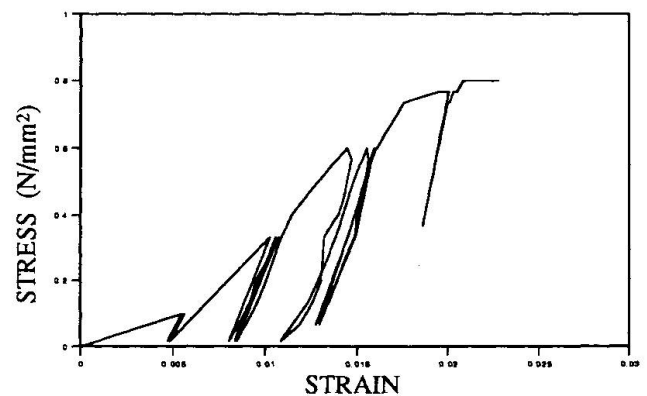
Fig. 3 - Average stress-strain curve - specimen 3.

The progressive opening of cracks did not prevent the material from exhibiting overall elastic behaviour in the individual loading cycles up to very high stress values, as confirmed by the diagram in fig. 3. This diagram illustrates a typical behaviour which was observed throughout the tests: the initial load increase, for each testing level, was accompanied by high strain values and marked residual strain, while in subsequent cycles (the load being the same) strain was lower and residual strain was virtually negligible.

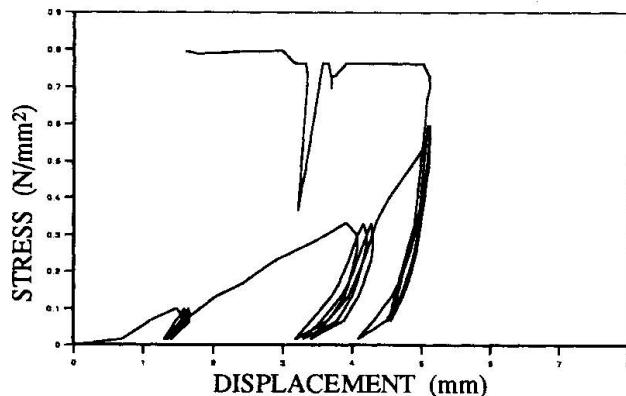
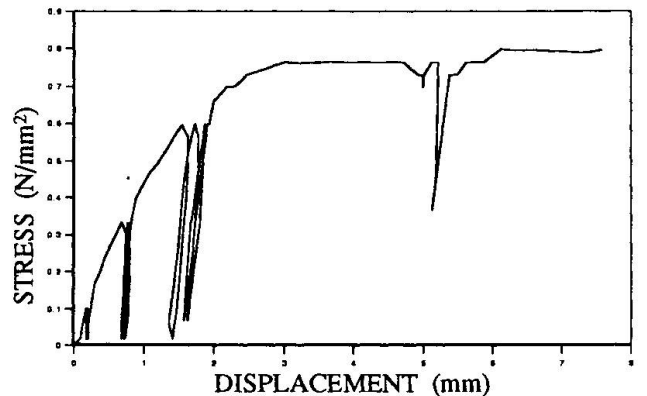
Figs. 4 - 5 - Stress-strain curve of strain gauge 4 (vertical) and 9 (horizontal) - specimen 3.

A comparison between the diagrams plotted from the readings taken by two strain gauges of about the same length on the same face of specimen No. 3 (figs. 4, 5), - a vertical and a horizontal gauge, Nos. 4 and 9, respectively - shows that the strain values are of the same order of magnitude and the horizontal one entails a transverse strain modulus about three times as high as that of the masonry at the elastic stage. Moreover, the downward portion of the curve in fig. 5 reveals a major overall settlement of the specimen under the load, this behaviour closely resembling that of specimen No. 1 already described above (fig. 6). Thus we find that the transverse strains that have been observed are greater than would be expected on the basis of the Poisson modulus of the components, and are independent - even in terms of their direction - of vertical ones in the proximity of failure. Failure involved the masonry specimen as a whole, as shown in photo 13. Strain stabilisation was especially slow at a load level corresponding to 90% of the failure load and required a waiting period of about 20 minutes, this being a confirmation of the major influence exercised by the permanence of the load on the collapse of very irregular masonry.

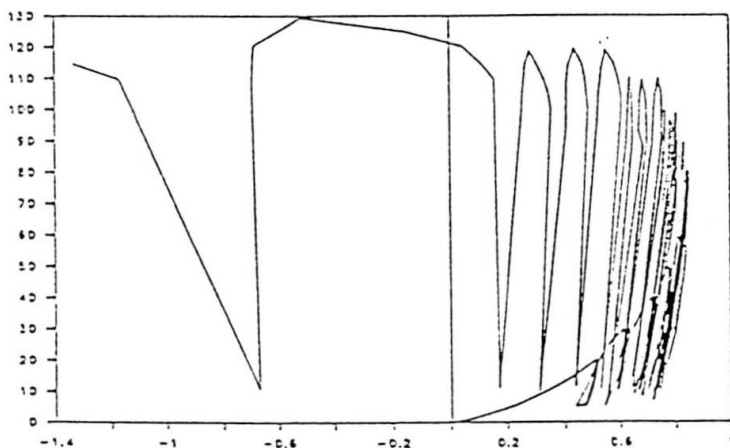
Fig. 6 - Load-displacement curve of strain gauge 5 - specimen 1.

In the case of sample No. 1, though care had been taken to apply the load to its centre of gravity, a marked compression and bending effect occurred due to the presence of a stiffer and stronger core in one of the corner area. Failure took place at 1180 KN (8.6 N/mm^2), during the second loading cycle of the last triplet, at a strain value markedly higher than that observed during the previous cycle where the specimen, however, had reached a load of 1300 KN (9.4 N/mm^2).
