## An Engineering View of the Statue of Liberty Restoration

### Edward COHEN

Managing Partner  
Ammann & Whitney  
New York, NY, USA

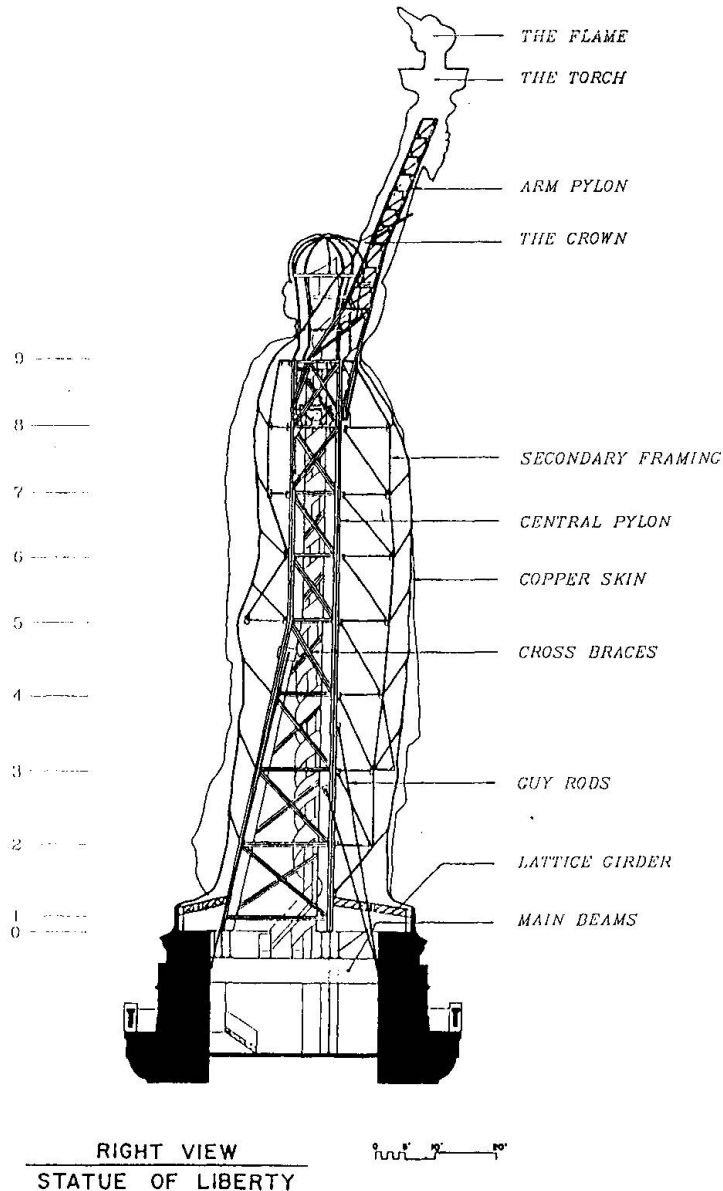
*Fig. 1 The Structure of the Statue*

Eiffel's design for the structure was innovative for his time (Fig. 1). This unique system consists of a trussed central pylon and secondary framing to support the copper skin and iron armature through an assembly of sliding and articulated elements which permitted "breathing" of the Statue under thermal and wind loadings. The most ingenious aspect of his design is the concept of flat bars to connect the skin support system to the secondary framework. The steeply inclined bars are installed in compression and provide the resilience to allow adjustment to changes due to temperature and

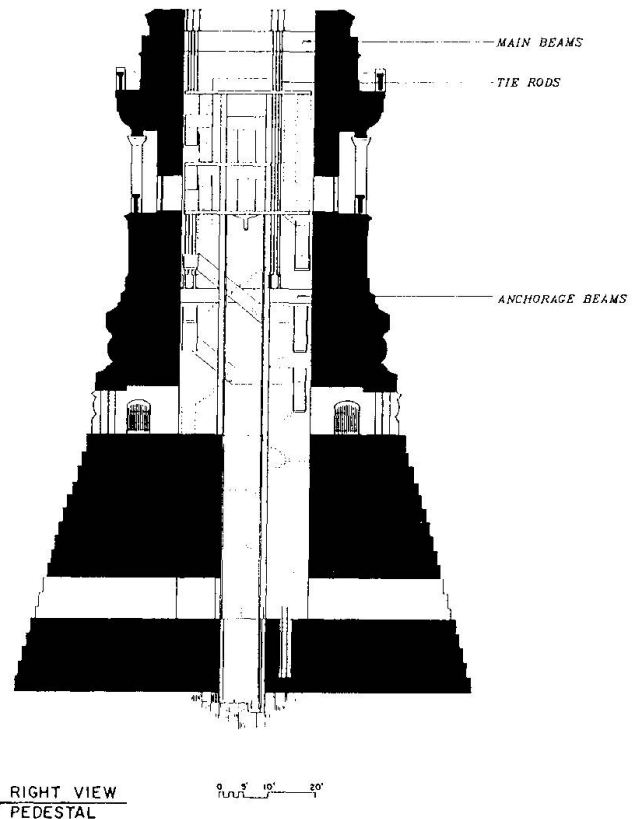
*Fig. 2 Foundation, Pedestal and Anchorage*

The pedestal (Fig. 2) is constructed of concrete of various mix designs. Above ground, the pedestal is faced with granite. At the time of its construction, the pedestal was the largest mass concrete structure ever built.

helped to identify two potential problems: weakness in the right shoulder and looseness of the anchorage of the Statue. The accelerometer measurements were taken to verify the results of the dynamic analyses in terms of the dynamic response of the Statue to wind, i.e., frequencies, accelerations and displacements. These measurements were correlated with wind measurements taken from an anemometer mounted on the torch platform.

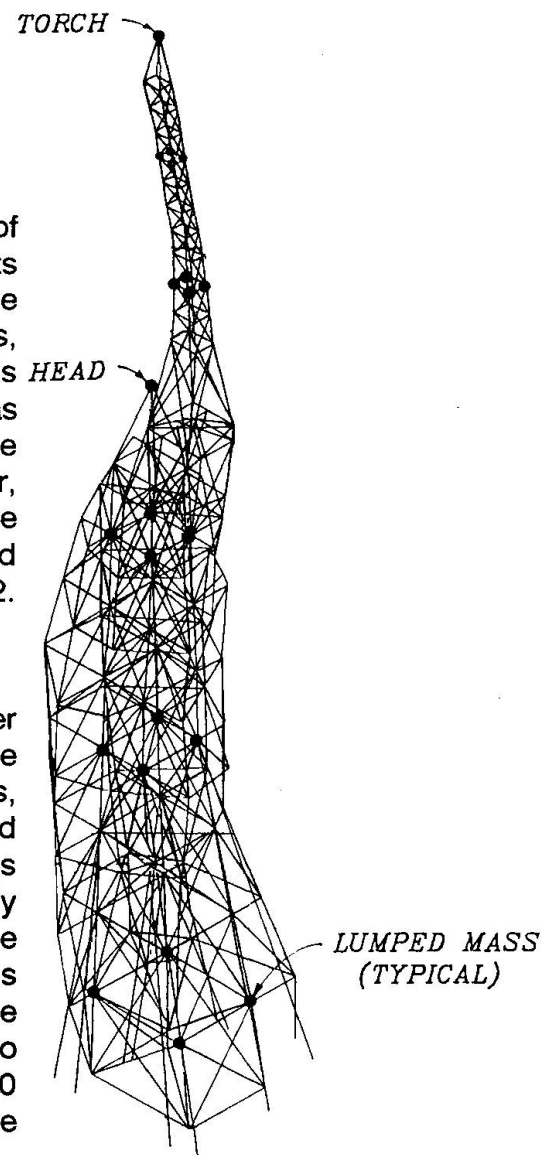
Fig. 3 Finite Element Model

The main pylon of the Statue, including the shoulder and the arm framing, was modelled as a three dimensional space truss. The geometric properties, including member sizes and makeup, were obtained largely from field reconnaissance surveys. Any stiffness contributed by the copper skin was conservatively omitted from the model; however, the influence of the "secondary" framework, which transfers the reactions from the skin to the main pylon, was included. The results of the dynamic analysis show that the two lowest modes, having frequencies of 1.66 hz and 1.90 hz, contribute over 95 percent to the response of the Statue under wind loads.
