**Zeitschrift:** IABSE reports = Rapports AIPC = IVBH Berichte  
**Band:** 44 (1983)

**Artikel:** Health and safety in the Humber bridge construction, 1973-1981  
**Autor:** Sparkes, Michael  
**DOI:** <https://doi.org/10.5169/seals-34081>

## Health and Safety in the Humber Bridge Construction, 1973 – 1981

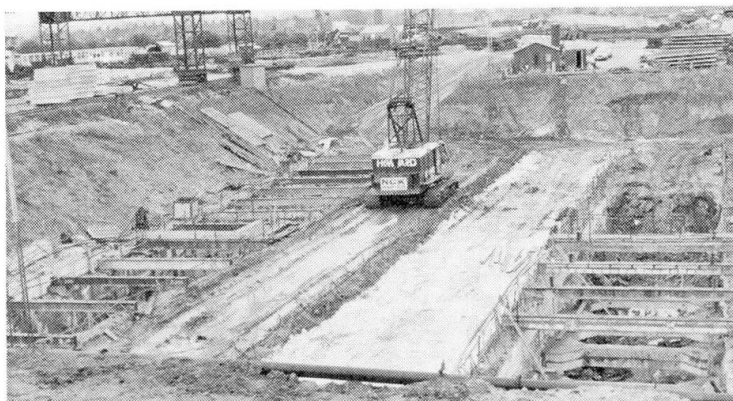
Excavation of the southern anchorage – strutting of longitudinal concrete walls.

Excavation in the chalk for the Northern anchorage was a safe procedure but in the wet clay on the south bank the ground had to be stabilised by sinking reinforced concrete longitudinal walls by Bentonite slurry injection methods to the full depth of 35 metres. Excavation then commenced between the walls which were strutted transversely as the excavation deepened. Both anchorages involved extensive use of scaffolding both below and above ground. Care was taken to en-

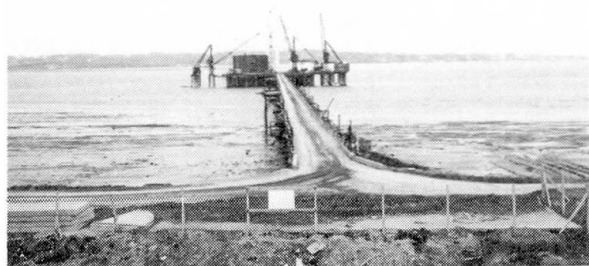
Construction of caissons at the end of the 500 m jetty.

hard clay. The construction of the caissons involved building a temporary jetty 500 metres long out into the river, capable of carrying heavy traffic. The caisson work involved the use of divers inside and outside the caissons to inspect progress during the sinking operation. Careful thought had to be given, in addition to the hazards involved in the diving operation, to the conventional problems of safe access and safe place of work. This involved the establishment of rigid rules for working over water where conventional safe working platforms could not be established, such as the provision of safety lines to which harnesses could be attached, the use of life jackets at all working positions where men were liable to fall into the water, and at all times when travelling by water and working from small craft. It also included the provision of adequate illumination for work which was done at night time. The accidents which occurred during this phase included several incidents of men falling into the water, usually when travelling from ship to shore or vice versa. There was one fatal accident during this phase also:- a small work boat fouled the mooring cable of a pontoon and was overturned by the fast current, which swamped the boat. Four of the men on board were saved, but the skipper of the boat was trapped in his cabin and drowned. This accident occurred as darkness approached. Thus rendering unsuccessful the helicopter search for the skipper's body.

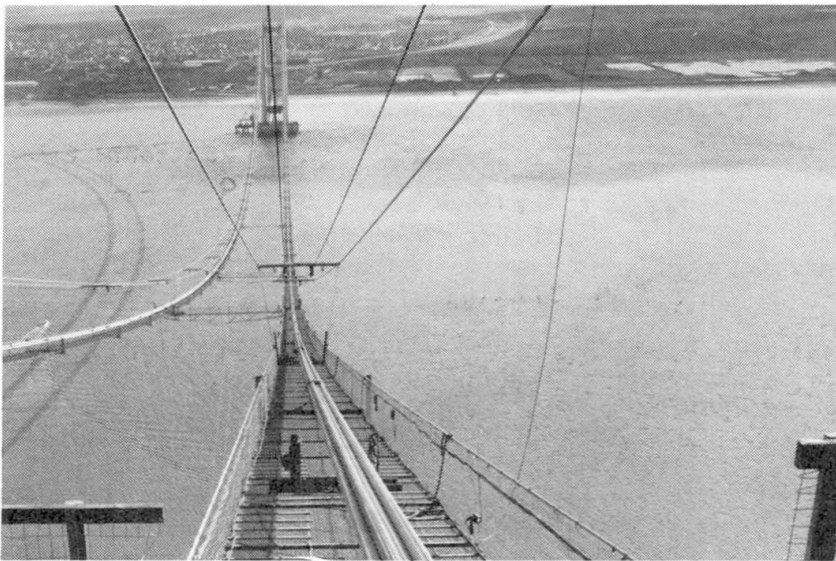
Each cable comprises 14,948 parallel galvanised drawn 5mm diameter wires, divided into 37 strands each of 404 wires.

Mainspan cable part way trough spinning process.
