Preservation of the state Oswiecim-Brzezinka museum

Zeitschrift: IABSE reports = Rapports AIPC = IVBH Berichte

Preservation of the State Oswiecim-Brzezinka Museum

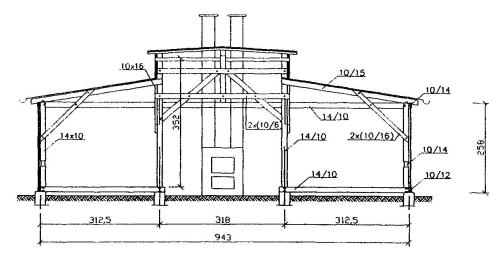
Fig. 1 The cross section of a habitable timber building

<u>Brzezinka</u> - on 175 ha of Brzezinka Museum 500 structures are situated. All structures were built during the war and had temporary character. Predominant part of all the structures is wooden and brick. Fig.1 shows cross section of a habitable building made by timber and brick.
