Zeitschrift:	IABSE reports = Rapports AIPC = IVBH Berichte
Band:	46 (1983)
Artikel:	Repair of damaged floor slabs
Autor:	Higashi, Yoichi
DOI:	https://doi.org/10.5169/seals-35874

Réparation de planchers endommagés Instandsetzung von Gebäudedecken

Yoichi HIGASHI Prof. Dr.-Eng. Tokyo Metropolitan Univ. Tokyo, Japan

The crack pattern and deflection of 48 damaged slabs in a 5-story reinforced concrete building with wide cracks and large deflections were measured. Two repair methods proposed were injection of epoxy resin into the cracks, and the casting of a concrete or mortar layer over the damaged slabs, depending on the degree of damage. Loading tests on one-way slab specimens similar to the actual slabs, and vibration tests on the actual slabs were carried out before and after repairing. The results of these tests show that the proposed methods of repair were very effective for the damaged slabs.

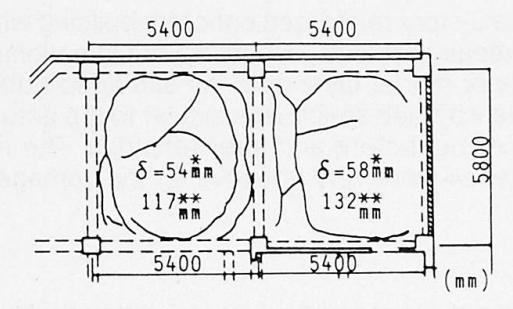
Fig.l Square slabs with wide span<sup>6)</sup>

construction year :1961
 girder section :350 x 700 mm
 design depth :130 mm
 natural frequency :
 (12.5-13.0 Hz,before repair)
 (18.2-20.5 Hz,after repair )
 \* : measured deflection at the center
 \*\*: measured depth

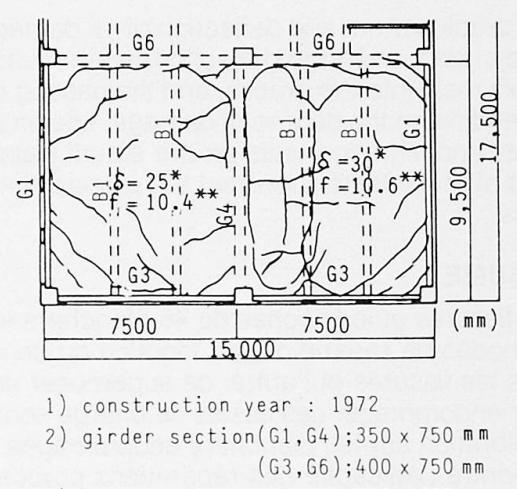
3) beam section B1 ;300 x 650 mm 4) design depth ;120 mm

\* : measured deflection at the center
\*\*: measured frequency

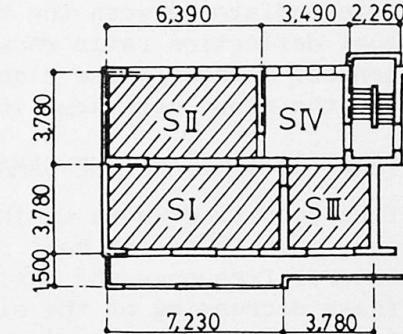
Fig.3 Plan of a flat

Crack patterns and deflection of 48 damaged slabs of 16 flats in a actual 5-story apartment houses of reinforced concrete wall structure were measured.<sup>5)</sup> The plan of a flat is shown in Fig.3. The slabs consisted of three types, namely, SI ( center to center span is  $3.78 \times 7.23 \text{ m}$ ), SI (  $3.78 \times 6.39 \text{ m}$ ), SII ( $3.78 \times 3.78 \text{ m}$ ).

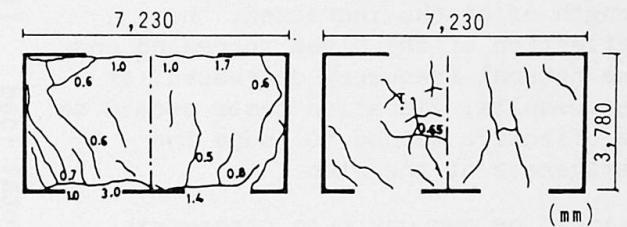
(a) Upper surface (b) Lower surface Fig.4 Crack Patterns of the most damaged slab

Fig.2 Slabs with beams in a office<sup>6)</sup> Building Figure 4 shows crack patterns of the most damaged slab. Cracks by constrain and shrinkage and by bending moment were mixed in the slab, but almost of wide cracks seemed to be by bending moment, judging from their occured place. There were many cracks whose width was more than 1.0 mm, and the width of a few cracks along the edges of short span reached 3.0 mm.

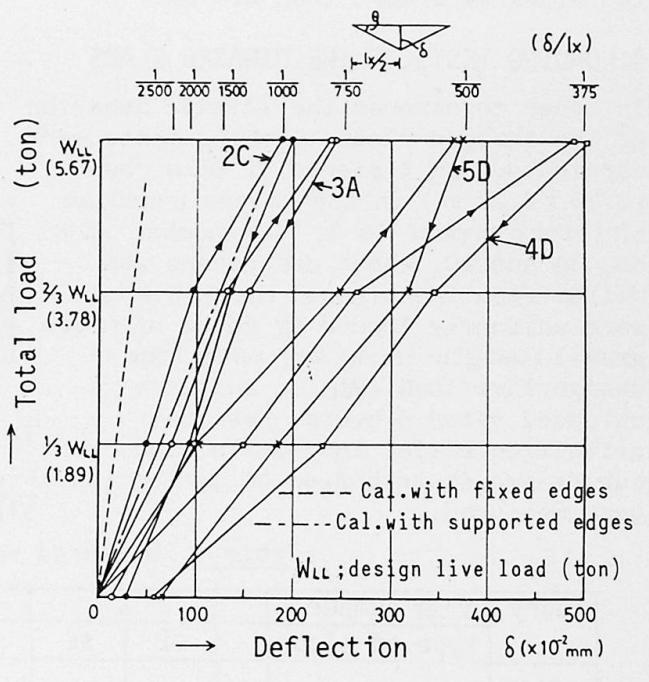
Figure 5 shows the load-deflection curves of the slabs. The values of calculated stiffness with fixed edges and with supported edges were shown by the dotted lines, in this figure. The stiffness of the slab in 2C, which were damaged little, was intermediate between the both calculated values. But the stiffness and residual deflection ratio showed tendency to be larger, corresponding to their damageness. However, these slabs were confirmed to have enough load capacity, because the slabs were kept in elastic under design live load, as shown in Fig.5.

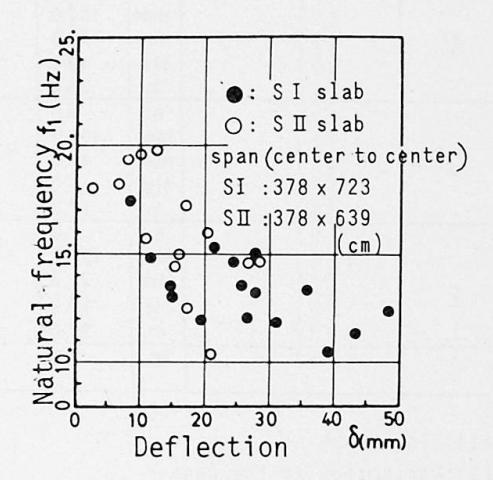
Fig.6 Vibration tests results

The free vebration waves of the slabs were measured by the pick-up for vertical motions, when the steel ball falled on the slabs from a heigth of 28 cm. Reading the natural frequency and maximum amplitude of the slabs from those waves, the stiffness decreasing of the slab was discussed.<sup>5</sup>) The tests results were shown in

Table 1 and Fig.6. It was found that the natural frequency decreased as the deflection of the damaged slabs increased. It showed a similar tendency to the results of other's studies.<sup>2),6)</sup> Judging from Table 1, as the total length of cracks increased, the deflection of the slabs increased and the natural frequency decreased. As the results, vibration tests seemed to be effective method to judge the damageness of the slab.

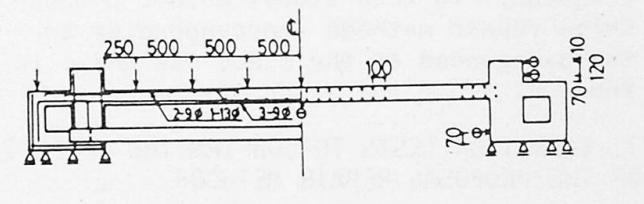
Each specimen was loaded by many oil jacks as shown Fig.7 until the residual deflection reached the values shown in Table 2, and was unloaded after cracks occured. And the specimens were reloaded

• : contact gauge
↔ : dial guage

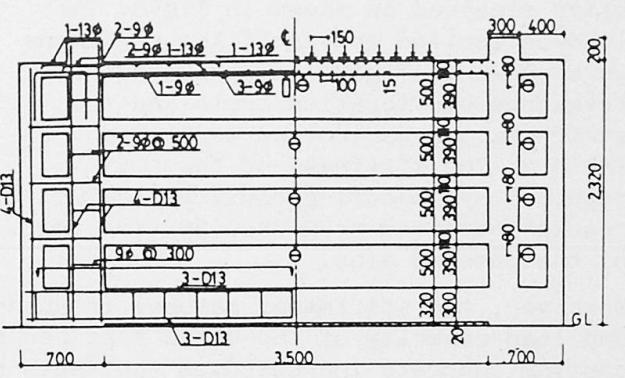
Fig.10 Specimens of long-term loading tests

8 one-way slab specimens of similar section and arrangement as shown in Fig.10 were uniformly loaded steel plates until the residual deflection reached the values shown in Table 3, and they were unloaded after cracks occured. After repair shown in Fig.8, the specimens were loaded under long-term live load for design ( $_{WLL}$  = 180 kg/cm<sup>2</sup>).

#### bar arrangement loading and measured points

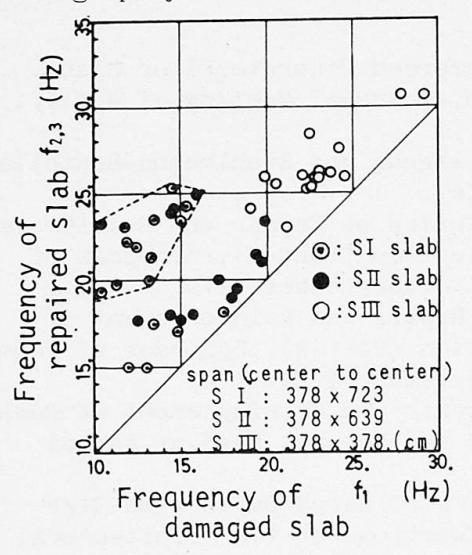
Figure 12 shows the change of the natural frequency of the slabs repaired by injecting epoxy resin into cracks. The natural frequency of repaired slabs increased about 20-30% than that of the damaged slabs. The measured results of the slabs repaired by casting mortal or concrete were shown in the dotted lines of Fig.12, and the natural frequency of such repaired slabs increased remarkably.

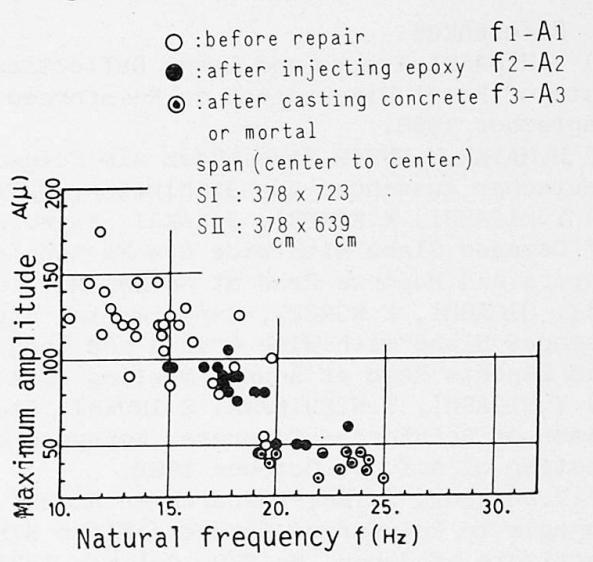
Figure 13 shows the relations between the natural frequency and maximum amplitude of the repaired slabs. The frequency increased and the amplitude decreased by injecting epoxy resin and still more by casting mortal or concrete.

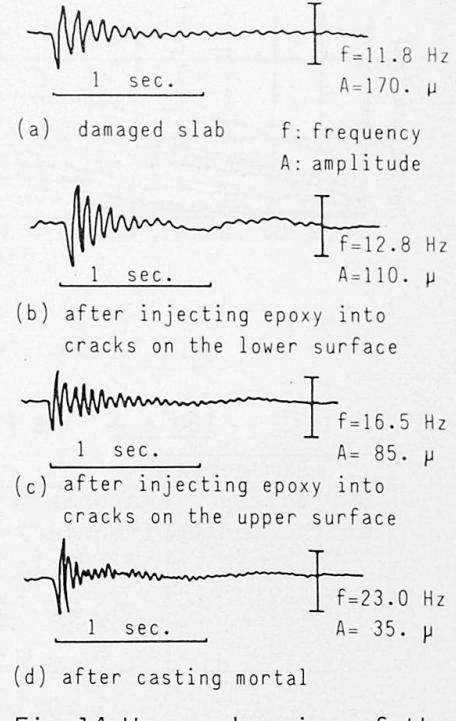
Figure 14 shows the change of the free vibration waves of the slab repaired by injecting epoxy resin and by casting mortal. The frequency of the repaired slab increased 2 times as large as that of the damaged slab, and the amplitude of repaired slab decreased 0.2 times as large as that of the damaged slab.
