| Zeitschrift: | IABSE reports = Rapports AIPC = IVBH Berichte | | | | |
|---|--|--|--|--|--|
| Artikel: | Strengthening of steel buildings against earthquakes | | | | |
| Autor: | Kato, Ben / Takanashi, Koichi / Tanaka, Atsuo | | | | |

Strengthening of Steel Buildings Against Earthquakes

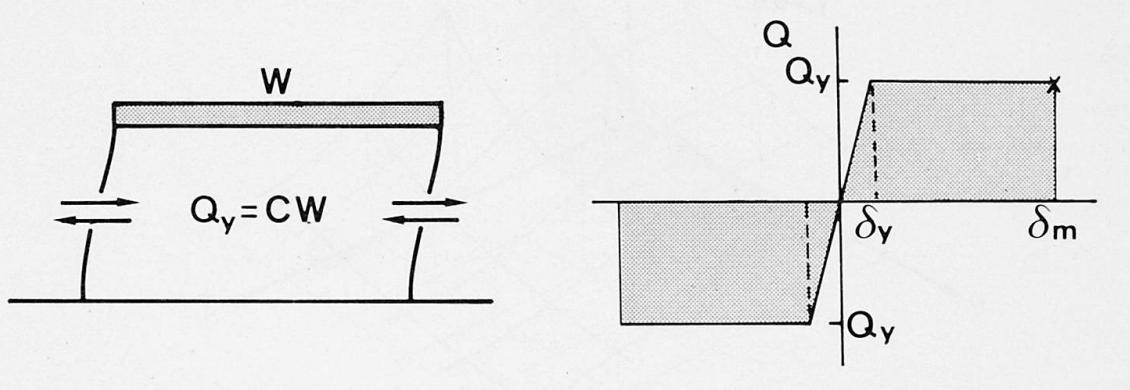
in which S_V = spectral pseudo-velocity response for undamped system and M = total mass of the structure. As a simple example, further derivation of the above equations will be done on a portal frame as shown in Fig. 1. In the case that the frame is yielded and undergoes considerable plastic deformation up to δm as shown in Fig.2, Eqs. 1 and 2 can be expressed as follows;

Fig.2 Story shear vs. sidesway relation Fig.1 A portal frame

$$\frac{1}{2} Mg^2 \omega^2 C^2 (1+4\eta) = \frac{1}{2} MS_v^2$$
(3)

in which g = the acceleration of gravity, ω = the natural circular frequency, C = the yield shear coefficient and N = the cumulative ductility ratio defined $\eta = \delta m / \delta y - 1$. After the vibration theory, as

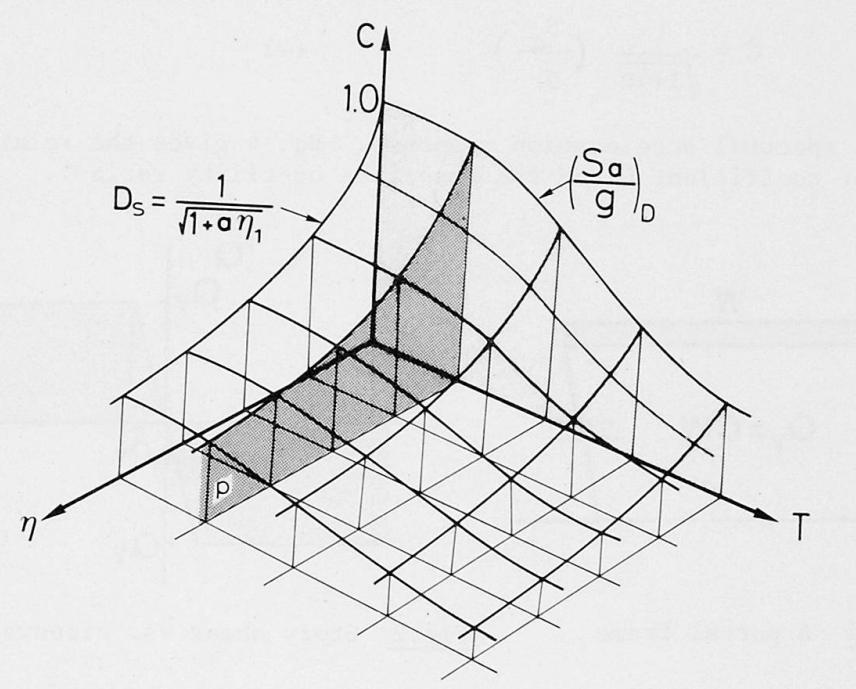
in which T_c = the specific period depending on the soil condition at the site. In a graphical way, the index can be represented by the curve in the C-T plane of Fig. 3. The required ductility ratio n_1 is dependent on the shapes of skeleton members. The possible ductility ratios must be evaluated for the width-to-thickness ratios of section shapes, the slenderness ratios of laterally unsupported members and the slenderness ratios of brace members in the braced frames. In the regulations of the Code the maximum value of the required yield shear coefficient C_1 is determined 0.5 for steel structure. In other words it is concluded that steel frames are expected to have some ductility. C_1 in Eq. 5 can be considered eventually a function of T and n_1 . Then the value of C_1 moves on a surface of the spreading roof shown in Fig. 3. According to the revised regulation of the Building Code, the design yield shear coefficient must be on or above the surface.

Fig.3 The same energy absorption level in the C- η -T space

In the case that the insufficiency in the strength and the ductility exists, the story shear coefficient C is plotted under the roof in Fig. 3. By the energy absorption concept similar to that described in the preceding article, there can be considered another roof on which C, η and T are related at the same energy absorption level.

Also the laminated roofs can exist for various levels of the energy absorption. Fig. 5 shows the section of such a structure made by the cutting plane denoted as p in Fig. 3. The solid curve represents the section of the roof required by the Building Code.

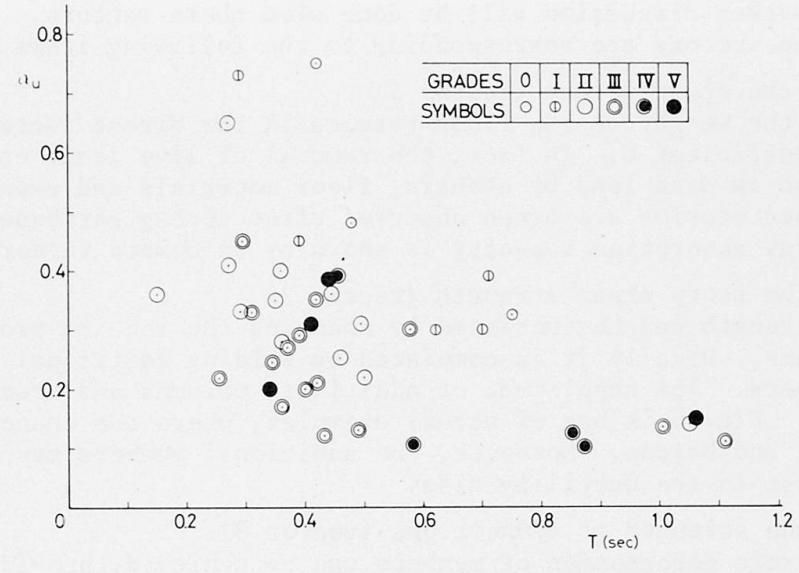
From the investigation results on the damaged steel buildings, the estimated maximum story shear coefficient α_u (the ultimate strength/the sustained weight) is plotted against the corresponding natural period of the building as shown in Fig. 4. The damage grades classified in Fig. 4 are:

(a) 0 = No damage, (b) I = No structural damage,

(c) II = Lightly damaged, (d) III = Moderately damaged,

(e) IV = Heavily damaged, (f) V = Collapse or Seriously damaged. The details of the damage analysis are reported in the literature[1]. Hence, further discussion is eliminated here. However, it must be stressed that in the shorter natural period range, higher shear coefficients are required to reduce the structural damage.

Fig.4 α -T relaton of damaged buldings

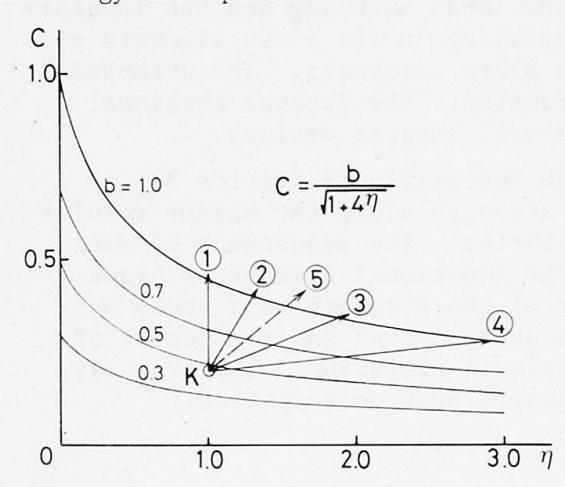
Fig.5 The same energy absorption levels in the C- η plane

By help of the methods suggested in the Diagnosis Standard, the existing C and η of an inspected frame can be estimated. Such a set of (η , C) represents a point like K in Fig. 5. The curve of b = 0.5, passed near point K in the figure, shows energy absorption level considerably lower than the design level. Therefore, the point K must be moved into the region above the solid curve by means of several methods for strengthening. The details of the proposed methods will be discussed in the next.

There are various methods for strengthening and repairing. Some of them are efficient in increasing the strength, namely, the yield shear coefficient C. Some are efficient in increasing the cumulative ductility ratio η or both of C and η . The amount of increase in C and η can be graphically expressed by a vector in the C- η -T space. The vectors in Fig. 5 represent the projections of such vectors. Regardless of the change in the natural periods of remedied structures, the further discussion will be done with these vectors. The numerals beside the vectors are corresponding to the following items.

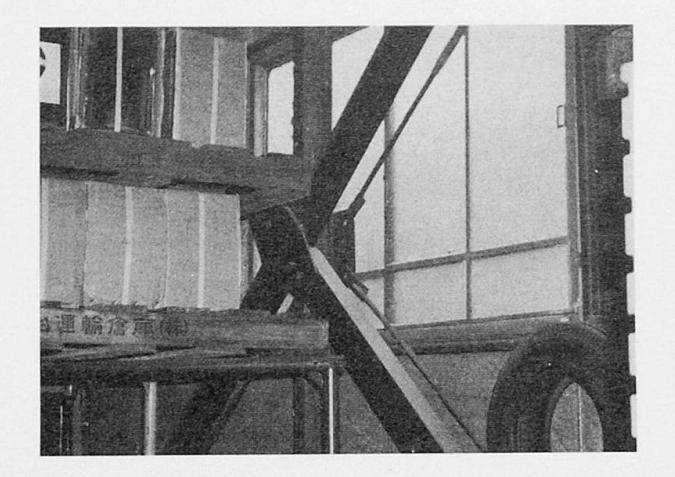
(2) Increase in the story shear strength (vector 2) The story shear strength can be increased by changing the section properties of columns and beams. Usually it is completed by welding additional cover plates to the members. The supplement of additional columns and brace members is most effective. Fig. 6 is one of actual examples, where the channel members are added to steel rod braces. Moreover, the additional members may sometimes produce the increase in the ductility also.

Fig.6 Channel braces added

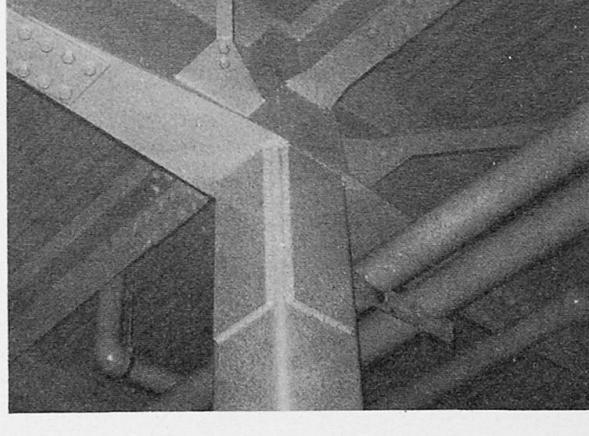
The member ductility is improved to avoid the local buckling and the lateraltorsional buckling in members. The local buckling in the plate elements of sections can be prevented by increasing the plate thickness. The attached coverplates as shown in Fig. 7 are also effective. The lateral-torsional buckling is prevented by properly placed lateral support devices.

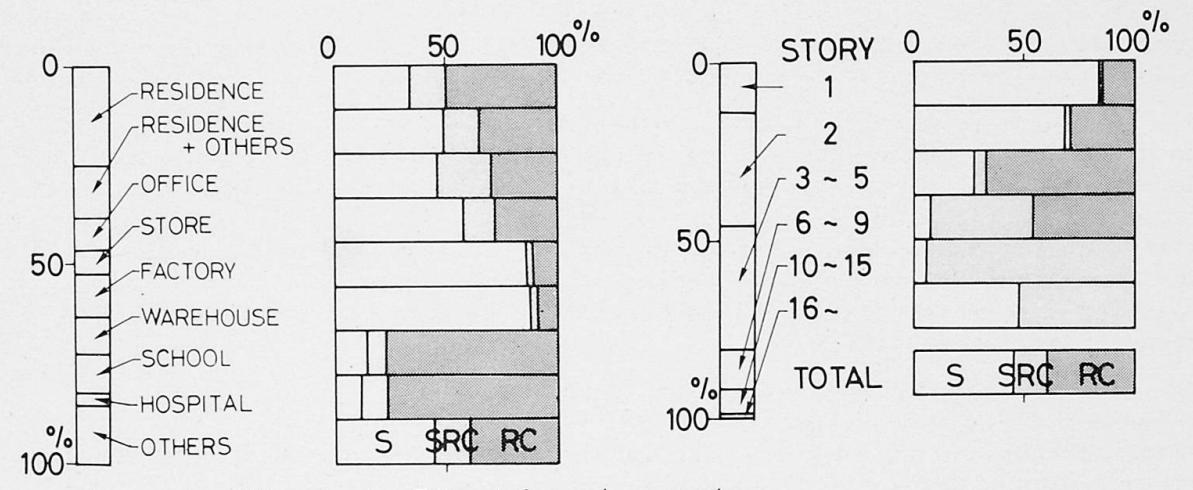
statistics of the annual total of newly constructed floor area in 1979 that steel structures are widely used for factories, warehouses and stores as shown in Fig. 8. Moreover, low rise buildings are often made of steel frames as shown in Fig. 9. Therefore, the inspection of earthquake resistance capacity of existing buildings and the strengthening become very important. In fact a municipal government set force their plans for strengthening houses along the Standard described in this paper. Some of them have been already examined and will be strengthened in the suitable methods.

S;steel, SRC;mixed, RC;reinforced concrete

Fig.8 Usage of three types of structures (right) in different types of buildings (left)

Fig.9 Usage of three types of structures (right) in different story buildings (left)
