Crossed wires – and surviving the consequences

John Jesson is intrigued by some complex electrical engineering

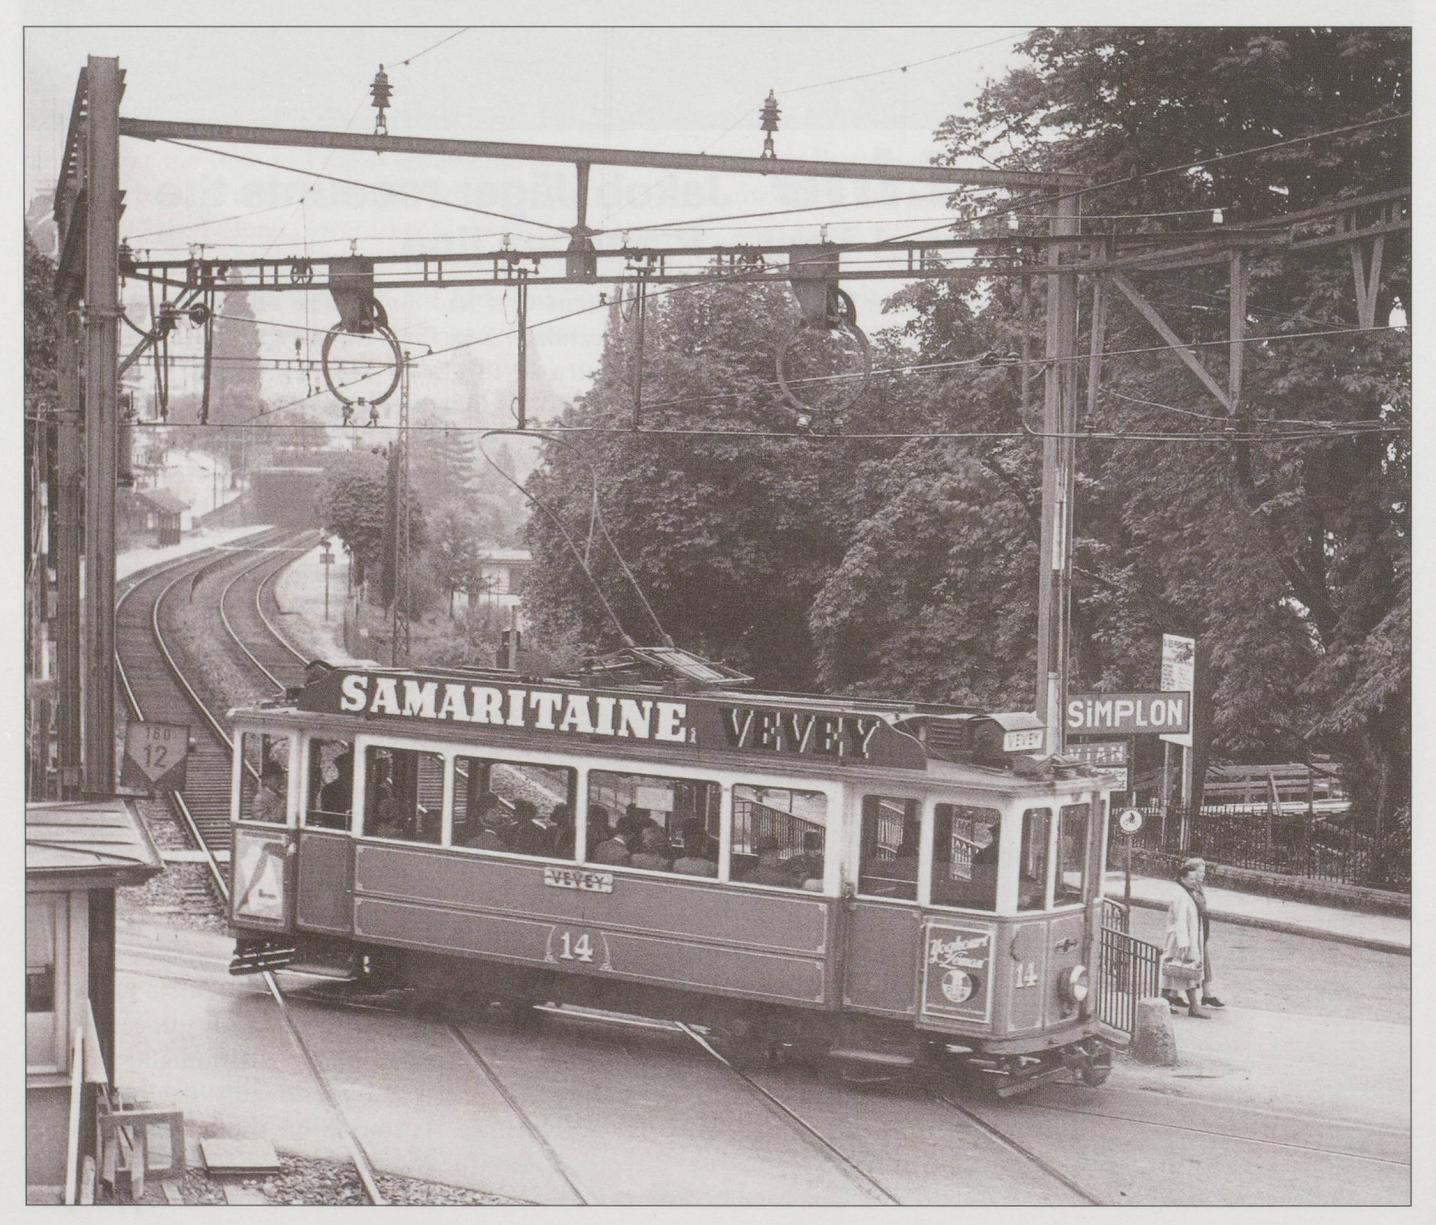
ramways crossing railway lines are not particularly common, but this old photograph taken of a Vevey-Montreux-Chillon-Villeneuve (VMCV) tram at Territet, shows the problem that arises when the railway line is electrified. On the one hand, there is the CFF main line railway with 15,000V ac running through its wires, on the other the tram route that was electrified at 600V dc with its overhead providing the power. In this case some engineering ingenuity solved the problem by installing a moveable tram wire.

There is quite a lot of ironmongery involved in the whole set-up, something that would not please today's environmental lobby! The high-voltage lines for the railway are supported by a cross girder, itself carried by two masts on opposite sides of the road. There are two additional masts (one out of the picture) at the other two corners of the junction. These are connected to the other masts on the same side of the railway by other girders and these, in-turn, support a long diagonal girder, supported halfway by supports from the first cross-girder. There seems to be additional ironwork across the road at the left of the picture and this is probably for the operating mechanism. The small cabin on the left probably contains the controls.

Across the level crossing, the tram overhead contact is not a wire, but four contact bars, each bent up at both ends to allow a smooth transition by the tram current collector. Two semi-circular hoops that are pivoted at their top ends surround each of the railway overhead contact wires. When the crossing is required for railway use, the hoops can be pivoted so that the tram contact bars are raised away from and above the railway contact wire. The four contact bars are each supported at one end by the semi-circular hoops and at the other by a long hanging support. From here on though the operation is less clear. The action of pivoting the hoop pushes one end of the contact bar away from the 15 kV contact wire and raises it above the level of the railway pantograph. The hanging support at the other end appears to be pivoted so that the bottom end (connected to the contact bar) is also pushed away from the 15 kV wire. However, as this hanging support is nearly twice as long as the depth of the hoop, the end result is that the end of the contact bar is dropped below its normal level. There seems to be some sort of operating mechanism connected to the hanging supports, but what this does is unclear. Although there is another known photograph of a tram using the crossing, it would be very helpful to see what the tram contact bars looked like when the crossing was set for trains. I have tried to show the complex layout on the accompanying diagram.

The tramline at this point was re-electrified in 1913 to the system shown, when the complex original 1888 electrical system of the Vevey-Montreux-Chillon tramway was replaced at the time of its merger with the Chillon-Byron-Villeneuve tramway to form the VMCV. This was some eleven years before this section of the CFF main line through Montreux went under-the-wires in 1924, so this photograph must have been taken after this latter event. The present day layout now has the main line running above the road, which dives under the railway with a short section of dual carriageway. Although increased road traffic flows were probably one reason for the grade separation of the crossing, no doubt maintaining the complex electrical arrangements added to the need for change. The trams ceased running in the 1950s but the VMCV's modern articulated trolleybuses still run under wires as they follow the old tram route. During the reconstruction the basic station seen behind the crossing disappeared, whilst today's Territet station is some 500m further east of the old crossing point.
