Zeitschrift:	Swiss bulletin für angewandte Geologie = Swiss bulletin pour la géologie appliquée = Swiss bulletin per la geologia applicata = Swiss bulletin for applied geology	
Herausgeber:	Schweizerische Vereinigung von Energie-Geowissenschaftern; Schweizerische Fachgruppe für Ingenieurgeologie	
Band:	20 (2015)	
Heft:	1	
Artikel:	Ground improving injections underneath historical buildings : five case histories as an overview of a technique	
Autor:	Berengo, Valentina	
DOI:	https://doi.org/10.5169/seals-632518

Ground improving injections underneath historical buildings: five case histories as an overview of a technique Valentina Berengo¹

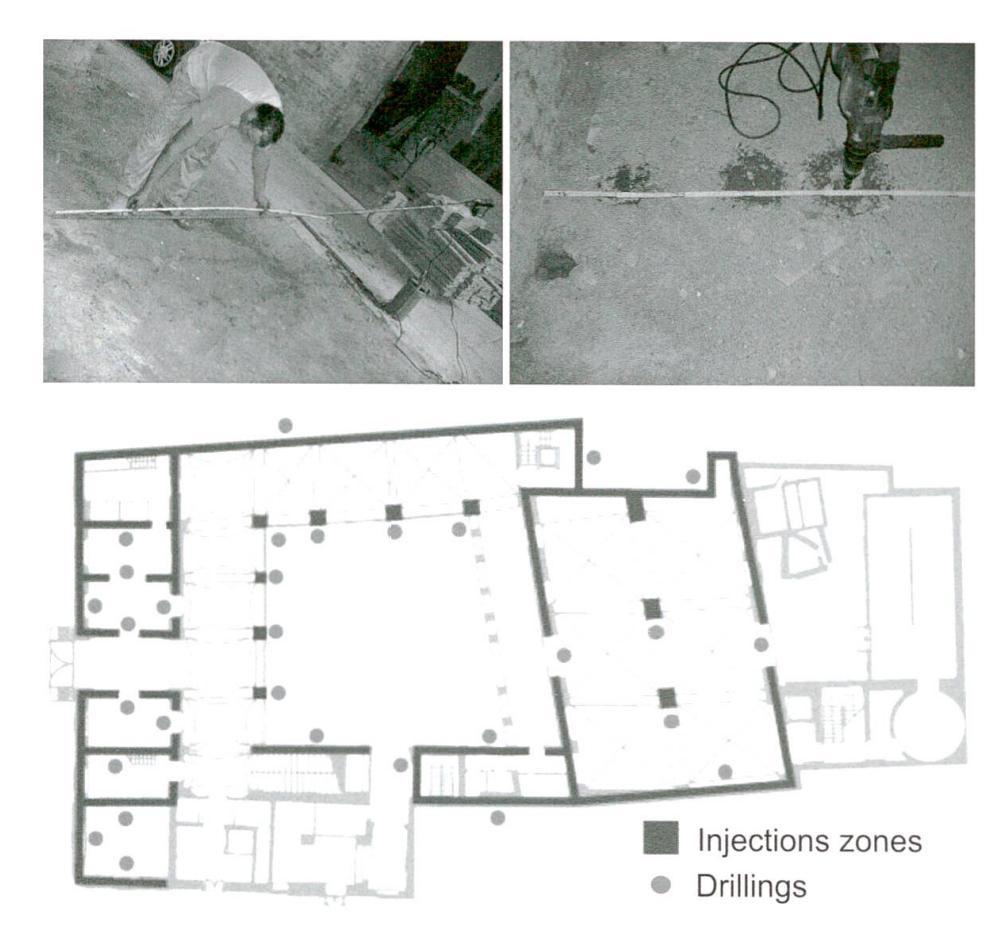
Fourteen different areas around the entire building were investigated (Fig. 2): walls were found to be constituted by bricks and binder with no discontinuities, the foundation base level varies from 0.5 m to 3.2 m depth and a 10–15 cm layer of crushed stones lies under the foundation system.

Fig. 2: Above: foundation survey at Palatium Vetus. Below: survey and intervention map.

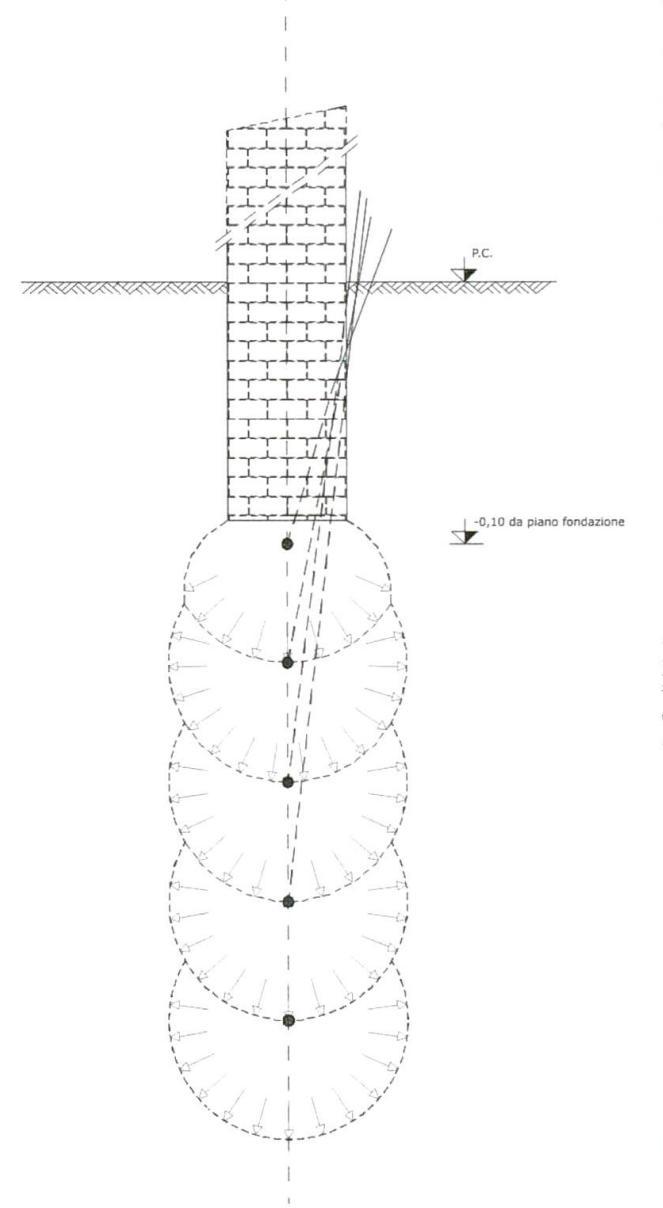
Fig. 3: Injection procedure.

The design was performed by means of Uretek software S.I.M.S. 1.0 described above. For further details the interested reader is referred to Pasquetto et al. (2011). The injections were performed on five different levels from the base level of the foundations until 3.5 m of depth (interaxis distance: 0.6 m) with manual boring machines identical to those used to investigate the foundations, which passed through the final part of the foundations themselves, existing as described in Fig. 3. In this way only light vibrations were guaranteed.

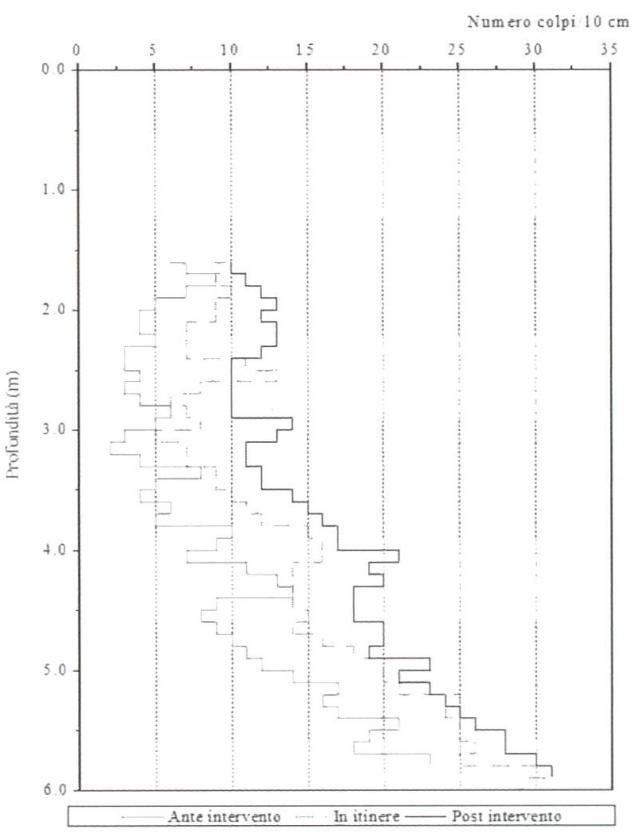
To test the improvement of the soil resistance, fourteen comparative penetrometer tests were performed in the treated zones, in accordance with Italian regulation (NTC 2008). Fig. 4 shows that mechanical properties increased more than 40% in the critical points, even though the test itself has no more than comparative meaning.

Fig. 4: Penetrometer tests before (light grey) and after (dark grey) intervention at Palatium Vetus (x-axis: number of strokes per 10 cm, y-axis: depth [m]).

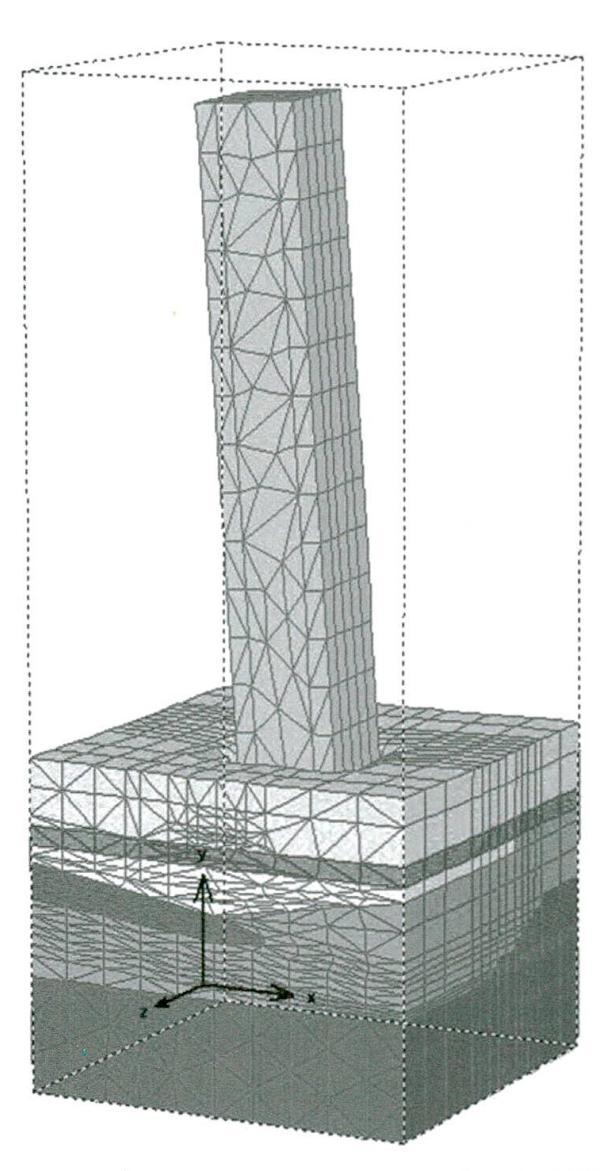
The tower was modelled in a vertical position in the input data. Afterwards, the construction phases were simulated using intermediate steps until the final configuration was reached (Fig. 5).

Fig. 5: Città di Castello tower mesh for the FEM analysis.

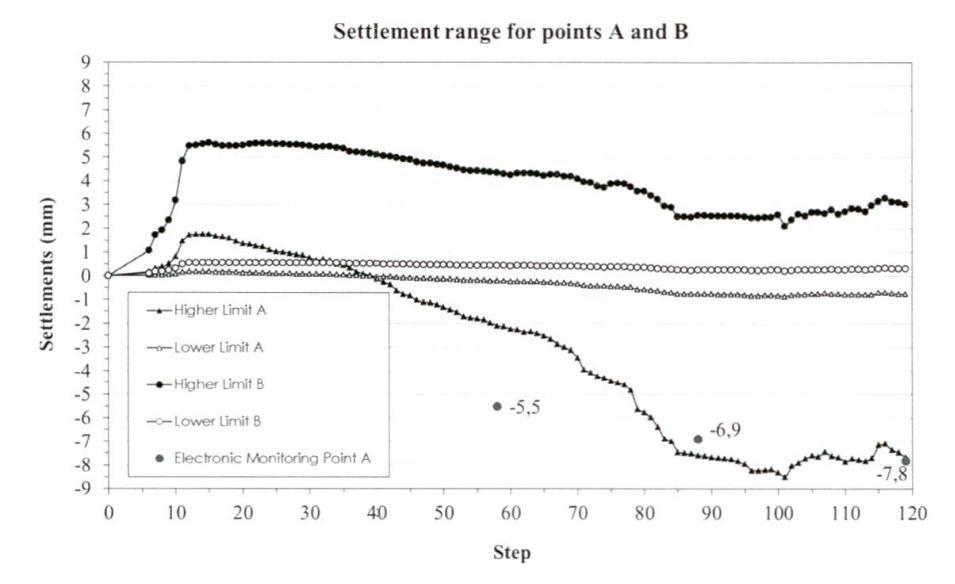
All throughout the work a real time electronic monitoring was operating. Fig. 6 shows how slight the differences are between the calculated time/settlement curve and the real settlement measurements after every injection phase, thus confirming the reliability of a numerical analysis that reproduces the resin injections.

Fig. 6: Time-settlement calculated curves and real measurements at Città di Castello tower.

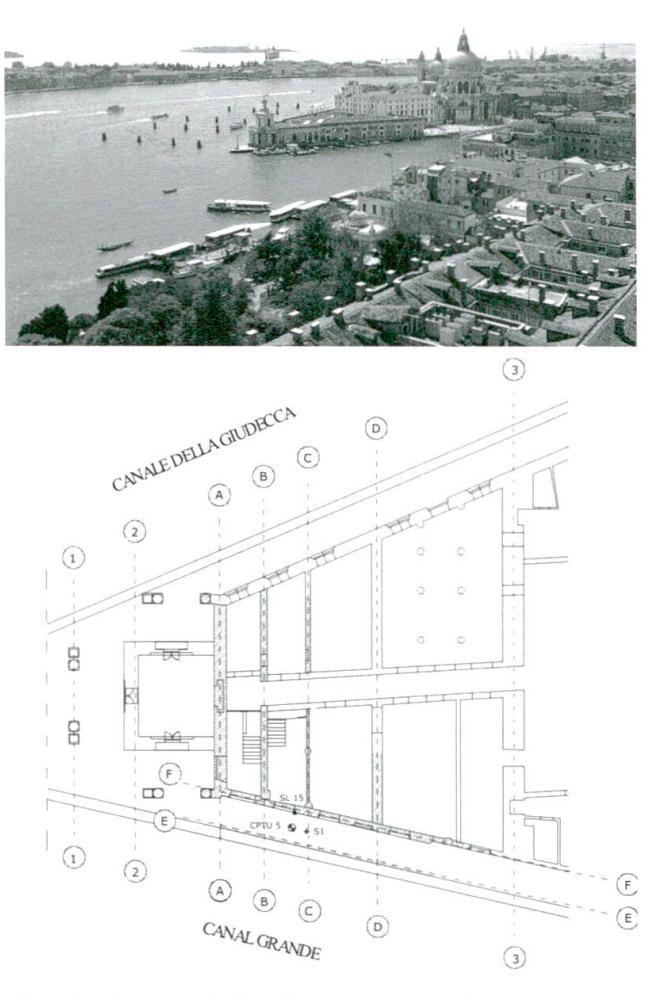
The main building has a width that varies from 16 m to 75 m and floors lie on ten brick walls, parallel to one another, as described in Fig. 7. Foundations are constituted by bricks and binder walls laying on four different substrates: directly on the soil, on a rigid shelf laid on the ground, on a shelf that lies on wooden piles or on the foundations of an existing tower. The foundation base level varies from 0.69 m to 2.84 m depending on the position.

Fig. 7: Punta della Dogana view (above), map (below).

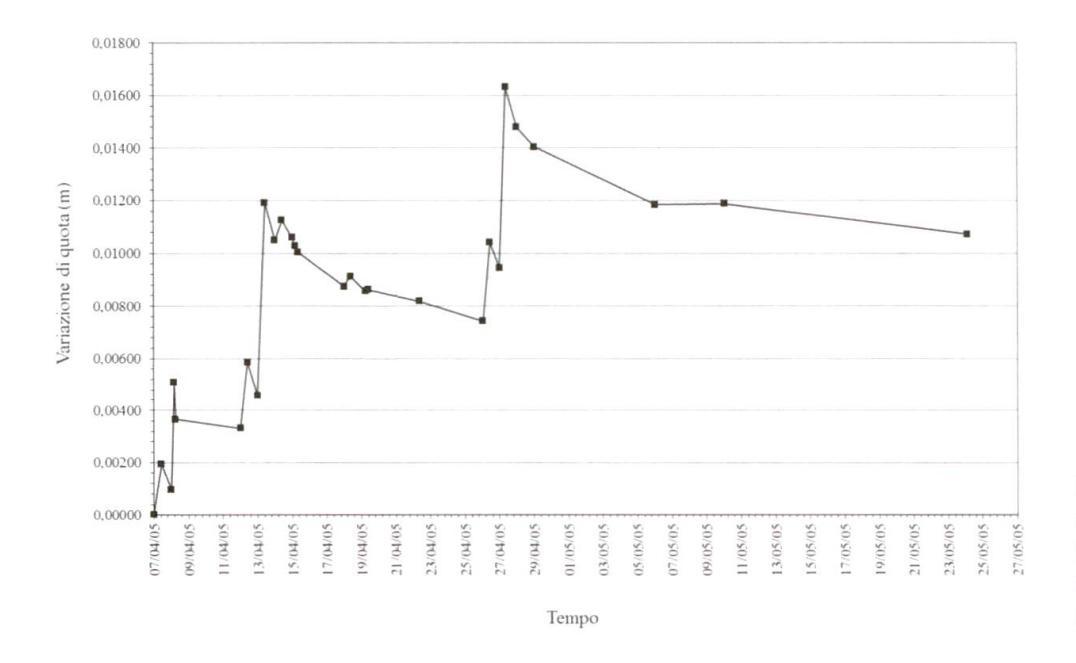
Fig. 9 shows the time-displacement curve of the check point «17», close to the SL15

Fig. 9: Time-displacement measured curve for «point 17» (x-axis: date, y-axis: displacement rates in m).

anchorage, on the «Canal Grande» side. The recovery is evident for each intervention phase.

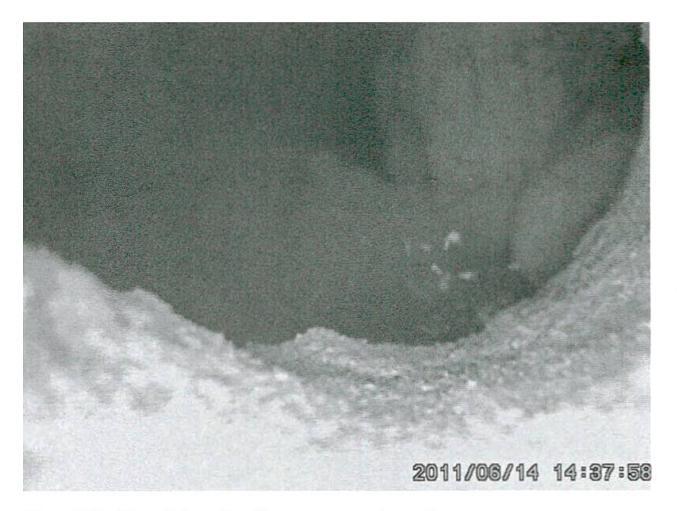
Visible differential settlements had already occurred at the time of construction, since the side laying directly on the soil started settling immediately. The first measurements go back to 1976 and now the maximum differential settlement between the two sides reaches 20 cm, while the rate of settlement is eight times faster than the initial one. The subsoil was also found to be constituted by several cavities, as detected during geotechnical preliminary surveys (Fig. 13).

Fig. 13: Cavities in Geneva subsoil.

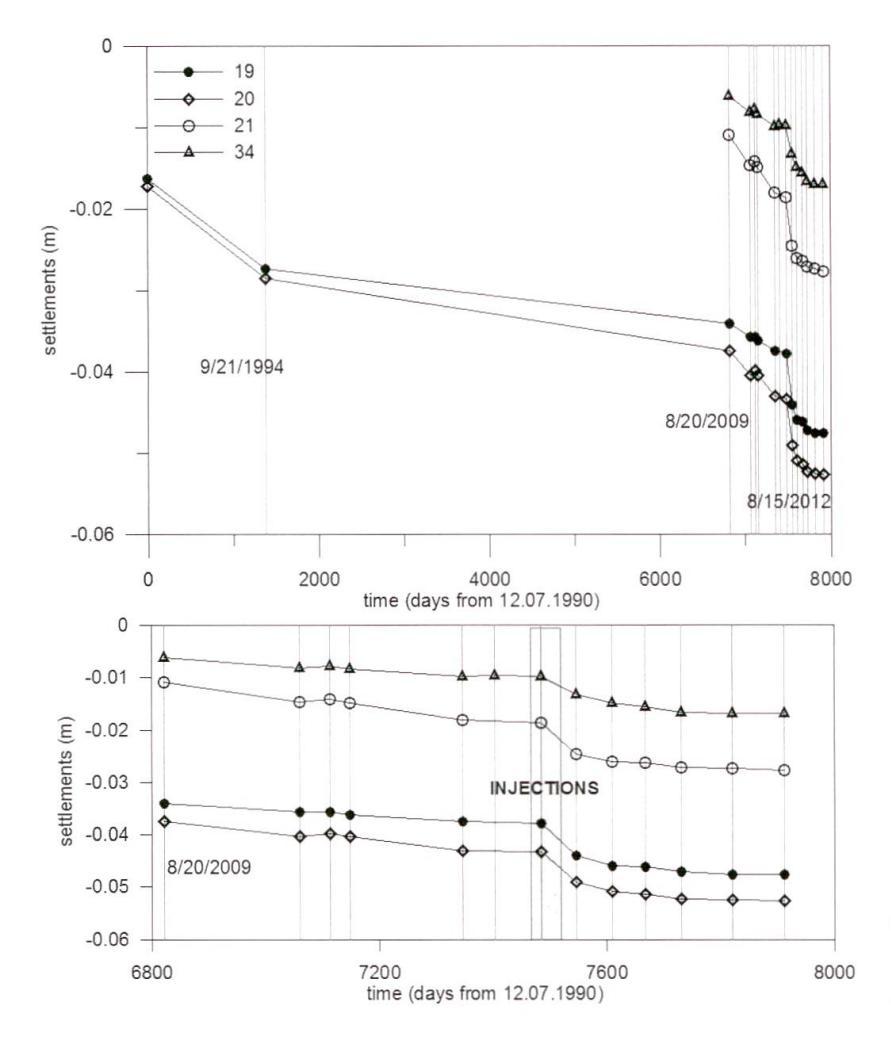
In Fig. 14 the settlement trend is plotted over

time in correspondence to fixed control points. It is clear that the settlement stabilized after the injection procedure. The injections cause a slight localized settlement due to the procedure itself, but the graph shows that the settlements which were increasing over time prior to the intervention have almost stopped.

Fig. 14: Above: time-settlement curves of several anchorages. Below: enlargement of the measurements just before and after intervention.

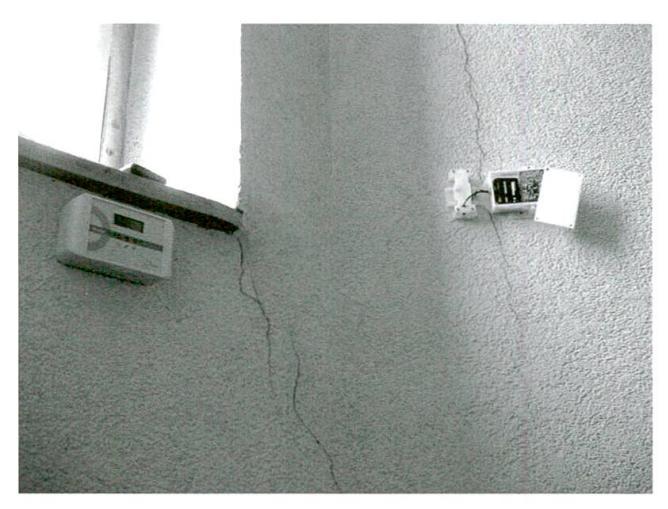
After the intervention a monitoring system called Easy Crack Monitor System® was installed in order to check the crack stabilization. The system allows for the automated and continuous reading of any relative displacement between two lips of a lesion and/or two buildings and/or two structural elements, along two orthogonal directions. It is composed of one or more reading devices in correspondence of the lesions to be monitored and by a central acquisition and transmission of data (Fig. 15). The reading device, rigidly connected to the masonry, detects the relative displacement

between two stiff portions along two orthogonal directions at regular time intervals. The reading of the movements is made at the same point for both directions, with a precision not greater than 0.5 mm. Each system is also equipped with a temperature sensor. The control unit has the function of collecting data from several reading devices and to transmit them by means of GPRS protocol, at regular intervals, to a server for storage and display.

Fig. 15: Easy Crack Monitor System®.

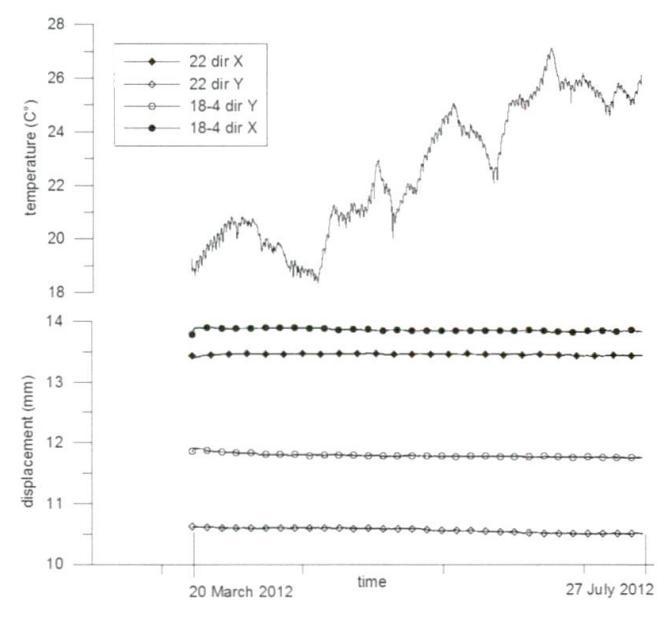
The monitoring results are shown in Fig. 16. The cracks stabilized since no more displacements occur along the X or Y directions, even when the temperature varied.

Fig. 16: Time- displacement-temperature curves for two cracks (in X and Y directions).
