Zeitschrift: IABSE congress report = Rapport du congrès AIPC = IVBH
Kongressbericht

Band: 14 (1992)

Plenary Session 2

Structural Contribution to Natural Disaster Reduction

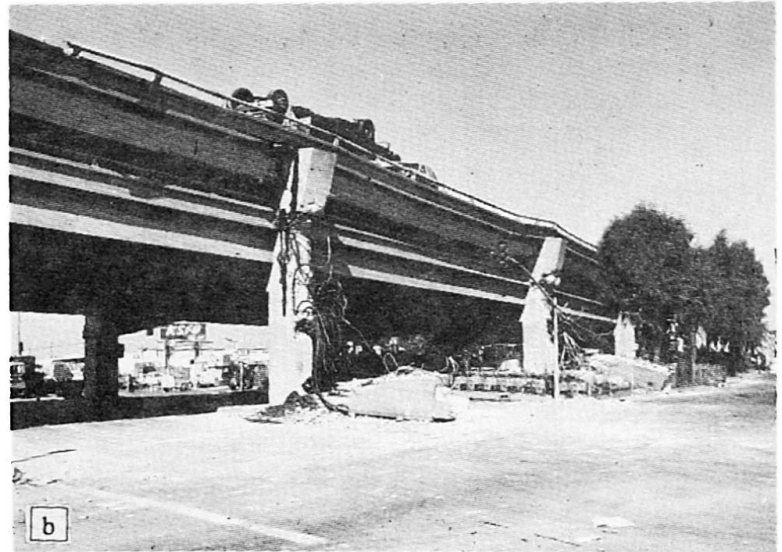
FIG 1. Bridge Damage During the 1989 Loma Prieta Earthquake

I-880
Oakland, CA
October 1989

Bridge damage and/or collapse is noticed mostly due to its impact on traffic circulation patterns following a major earthquake. Quite often, it is the bridges most needed for post-earthquake search and rescue and relief operations which are collapsed or have to be closed. The duration of closure directly impacts the economic post-earthquake recovery of the affected region. Again, while many seismic bridge problems (see Fig. 1) can be associated with the choice of the structural system, the earthquake hazard also could have been mitigated by appropriate design
