Artikel: Fabrication survey of steel components facilitates quick bridge erection

Fabrication Survey of Steel Components facilitates Quick Bridge Erection

Details of the fabrication survey, allowable tolerances, measurements, trial assembly and their favourable effect on the speed and accuracy of erection are described for the second Hooghly Bridge in Calcutta.

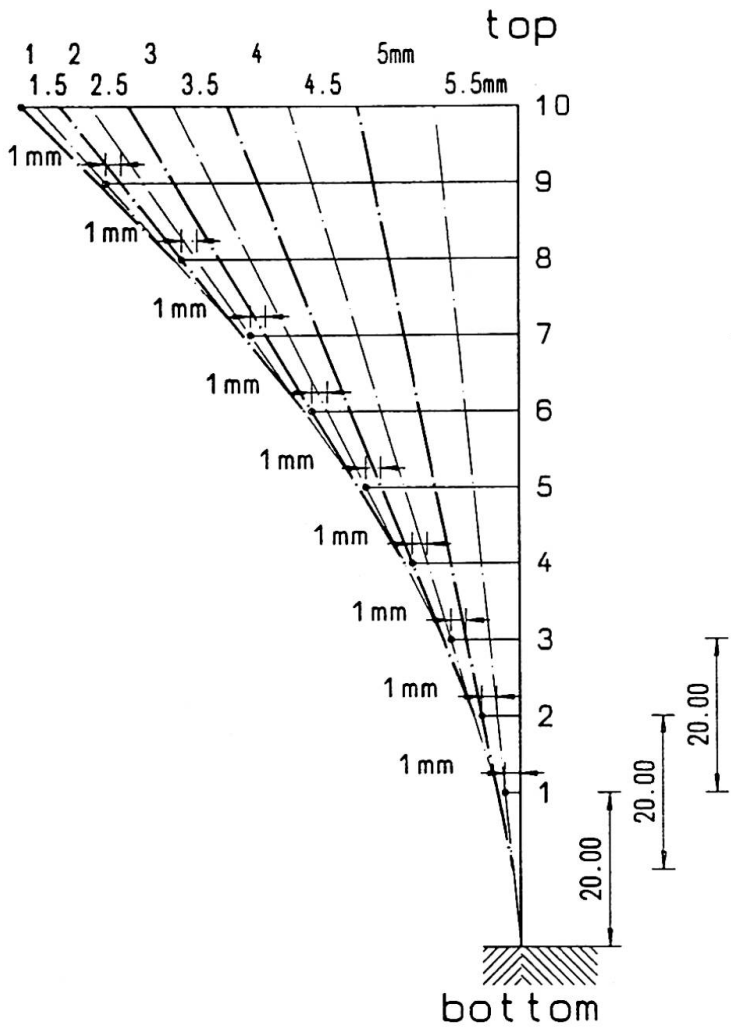
An additional, but undetected deviation from the axis occurs due to a built-in error in survey procedure. Considering a 1 mm error per control assembly survey and assuming that the error accumulates in same direction for further assemblies, the deviation from nominal axis at the top amounts to 32.5 mm taking entirely 10 nos. of assemblies and the reference length is 20 m per assembly (see Fig. 3).

Fig. 3
 Undetected deviation from nominal axis due to accumulative built-in error in control assembly survey, 10 nos. of assemblies with reference length of 20 m for each assembly lead to an eccentricity of 32.5 mm at top if built-in error is 1 mm per assembly.

The undetected deviation at the tower top will increase with less reference length per assembly and more numbers of surveys. For that reason it could not be agreed to control assemblies with 3 or even 2 sections only.

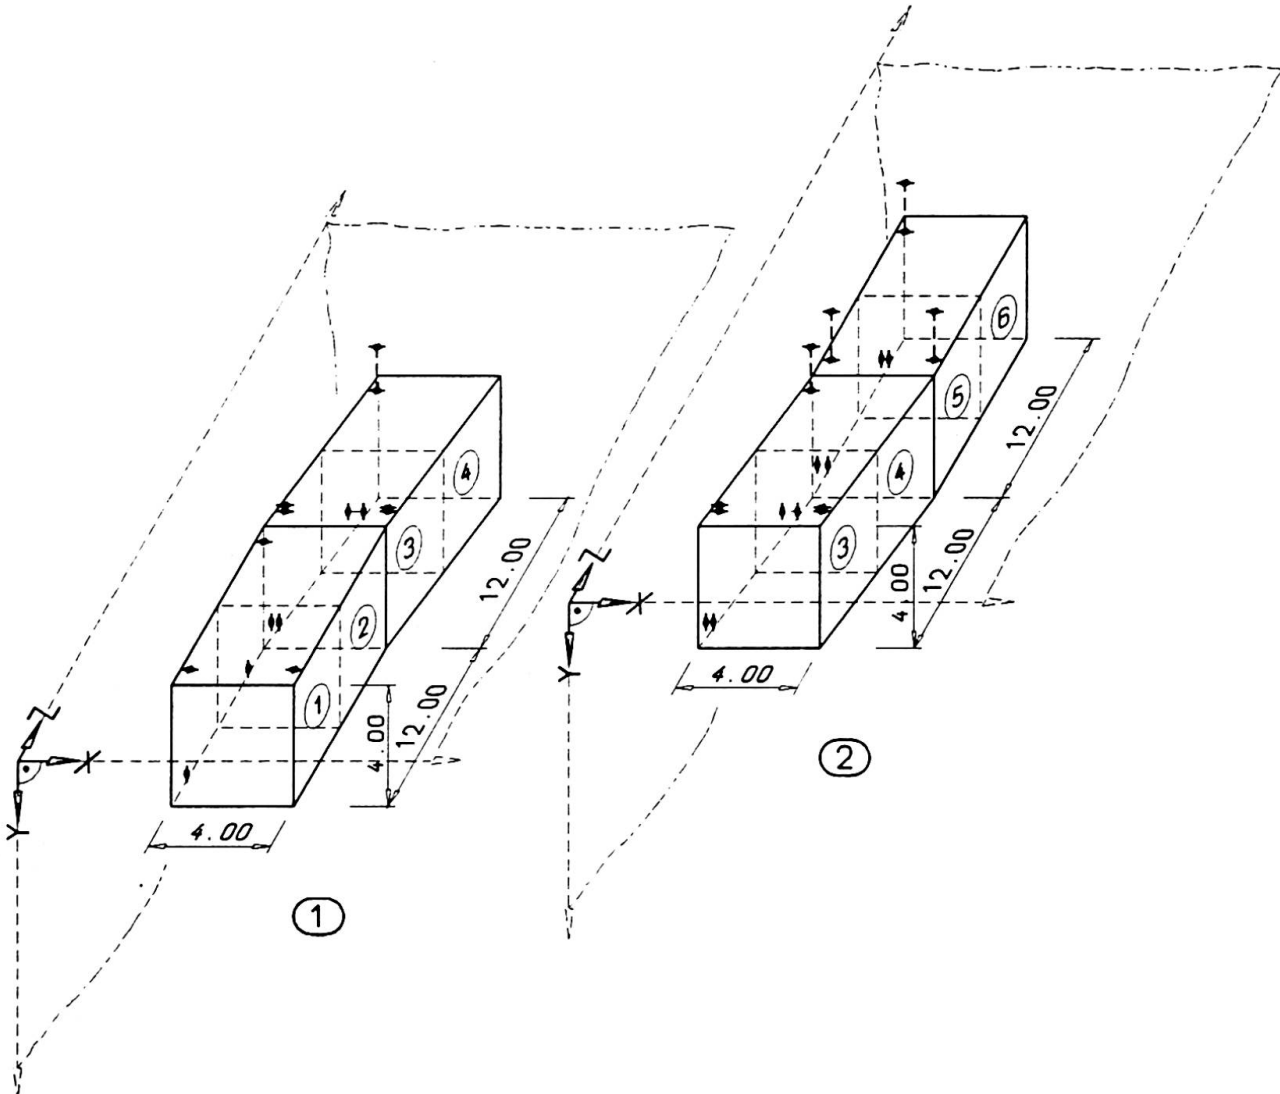
Shop floor survey for pylon legs has been executed with 4 sections per assembly horizontally laid out starting with base elements. By removing 2 rear sections and adding 2 sections at the front next assembly configuration was found. In Fig. 4 survey procedure for pylon legs is shown in principle for two subsequent assemblies. With a theodolite two perpendicular optical planes have been established. The intersecting line of these two optical planes represents nominal pylon leg axis. The offsets from the optical planes towards the wallplates of box sections were measured by scale in x-and y-direction. As a result, deviations from the axis were recorded.

Sequence of control assembly for pylon leg, offsets at boxes 3 + 4 in assembly (1) are identical to offsets at same boxes in assembly (2) achieved by analytical transformation.

1/750 of length, i.e. 140 mm in longitudinal direction of bridge at top portal level. It may be mentioned that setting of individual pylon legs at site was done with 4 elements corresponding to first control assembly at shops. By using identical shop survey points at site and relying on sufficient reference length of 4 sections an accurate profile for pylons was achieved.
