**Artikel:** The application of pre-stressing in dams

## VI 7

### The Application of Pre-Stressing in Dams.

M. Coyne,

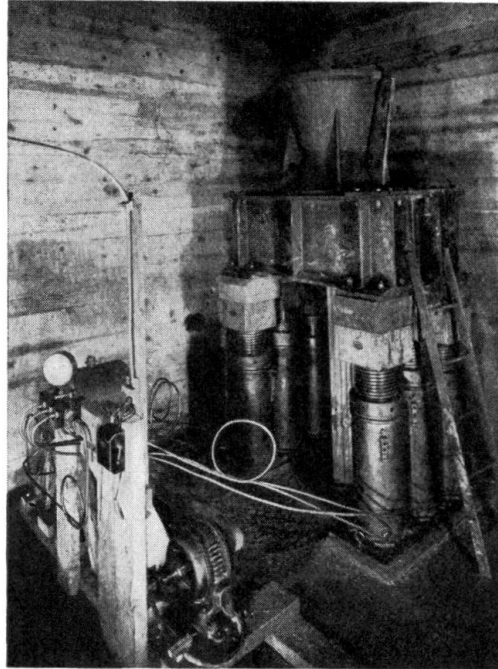
Fig. 15.

Marèges dam; anchorage of gravity abutment. Tensioning of tie by means of six hydraulic jacks.

sary at Cheurfas, where the application was made the first time in difficult ground — for instance it should be unnecessary to enlarge the bottoms of the shafts and to provide the thies with a plastic protective cover; the tie could simply be introduced without any special preparation into a hole *not enlarged*, at the bottom of which an accurately pre-determined amount of cement grout would be introduced as in ordinary sealing work. Finally, after the tension had been imposed, the hole would be filled with concrete from top to bottom. Moreover the use of cables prefabricated in the workshop would greatly simplify maintenance on the job and would considerably reduce the cost (Figs. 10 to 15).
