**Artikel:** Aerodynamic stability of long-span box girder

**Autor:** Tanaka, A. / Miyashita, C. / Nomura, N.

# AERODYNAMIC STABILITY OF LONG-SPAN BOX GIRDER

Tozaki Bridge is the north approach to Ohnaruto Br. (suspension bridge) of Kobe-Naruto Route, Honshu-Shikoku Bridge Project, Japan. Tozaki Bridge is 2 sets of continuous box girders and has slender configuration with large overhanging brackets.

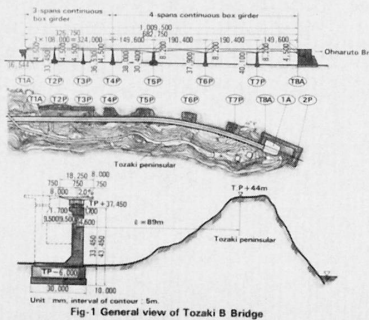
Fig-1 General view of Tozaki B Bridge

The bridge was to be constructed along a steep ridge called Tozaki which faces the Pacific Ocean. Thus, strong wind is expected so that the basic wind speed which is defined as 10 minutes average speed expected to occur once or twice in 150 years is decided to be 50m/s. And, bad influence by the topography was also anxious.

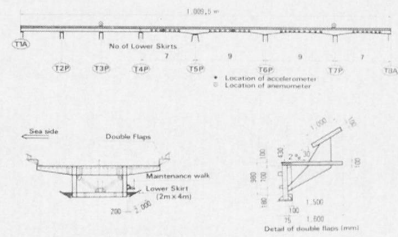
Fig-5 Actually adopted stabilizers and location of sensors

As the results of a series of wind tunnel testings, the final stabilizers were determined as follows: Double flaps were attached to the whole length of the bridge in order to restrict the amplitude of vortex-induced oscillation less than 200 mm ( $H/B=0.01$ ) which was the allowable value from the viewpoint of fatigue and runnability of automobiles. And, intermittent lower skirts to suppress galloping which might destroy the bridge in a short time if it appeared were provided to the 4-spans continuous girder. After the completion of the bridge in the summer of 1983, oscillation and wind have been observed, but no considerable oscillation has been generated so far, because no strong wind beyond 20 m/s has unfortunately blown.
