**Artikel:** Widening of existing bridges: a case study

**Autor:** De Brito, Jorge / Branco, Fernando

## Widening of Existing Bridges – a Case Study

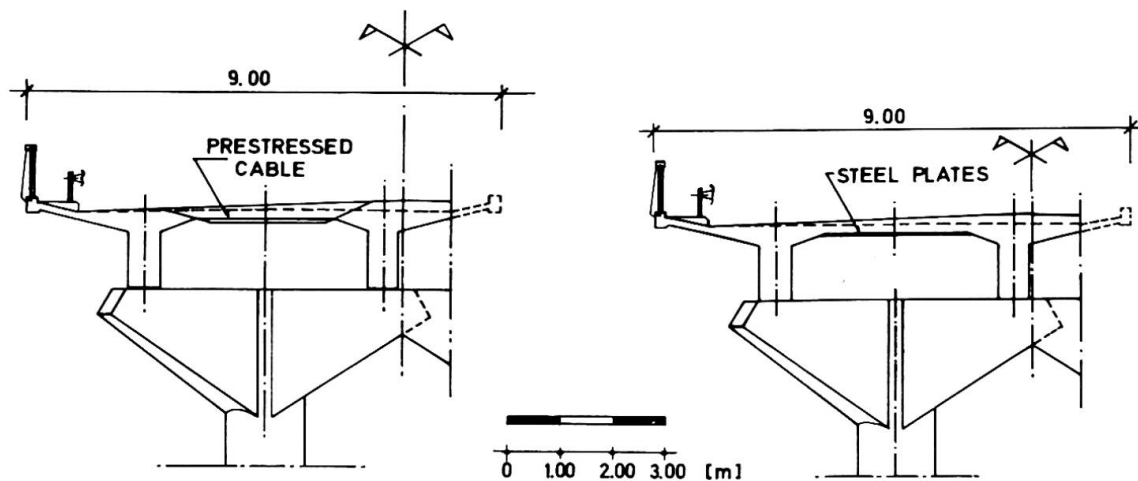
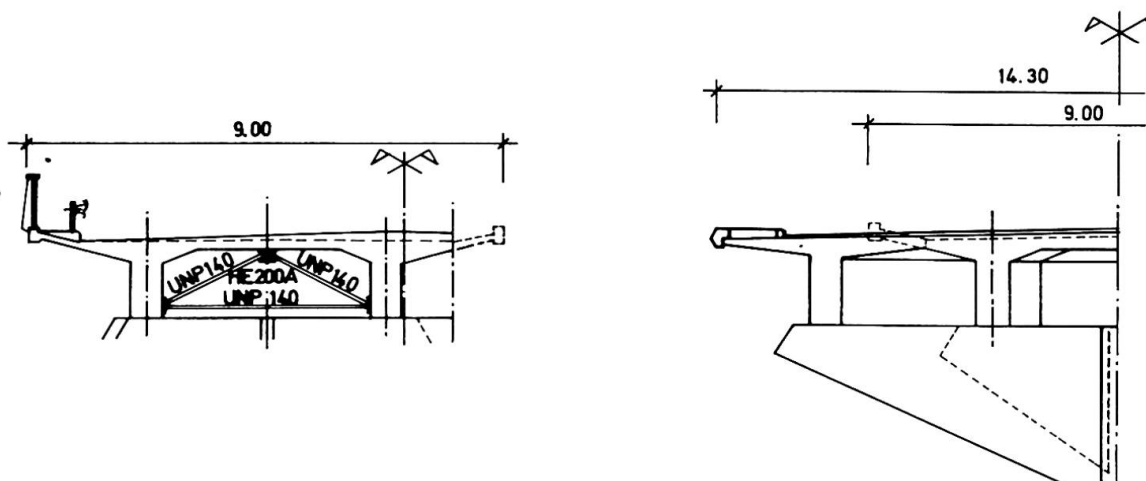
**Fig.1** Alternative systems for widening the deck of a rural bridge and simultaneously strengthen the existing slab

1st Solution (Road axis changes):  
DYWIDAG 20F strand cables spaced 0.50 m in the longitudinal direction anchored at the top of the slab. The anchorages are to be sealed with epoxy mortar.

2nd Solution (Road axis changes):  
steel plates with 2800x250x4 spaced 1.00 m in the longitudinal direction glued and riveted to the concrete.

3rd Solution (Road axis changes):  
metallic frames spaced 2.00 m in the longitudinal direction on top of which rests a HE200A beam. The frames are connected to the longitudinal beams through plates riveted to the concrete.

Final Solution (Road axis constant):  
thickening of existing slab and introduction of additional ordinary steel reinforcement over the longitudinal beams.

To account for the increased loads in the existing deck three different solutions for slab strengthening were studied: one with the introduction of pre-stressed steel, the second using steel plates glued with epoxy and riveted on both ends and a last one using a three-dimensional metallic frame (Fig. 1).

The other situation led to a solution where the widening of the deck was done symmetrically to both sides. Two extra longitudinal beams had to be built and the existing columns were significantly thickened which changed the outside look of the bridge. The existing bridge deck slab had to be thickened to account for the transversal sloping of the road which made it possible to avoid an external system of strengthening by using additional reinforcement. The columns foundations were enlarged. Due to traffic conditions, this last solution was adopted.
