Zeitschrift: IABSE proceedings = Mémoires AIPC = IVBH Abhandlungen
Band: 10 (1986)
Heft: P-104: Fatigue strength of tension flanges with stud shear connectors

Artikel: Fatigue strength of tension flanges with stud shear connectors
Autor: Maeda, Yukio / Kajikawa, Yasuharu
DOI: <https://doi.org/10.5169/seals-39613>

Fatigue Strength of Tension Flanges with Stud Shear Connectors

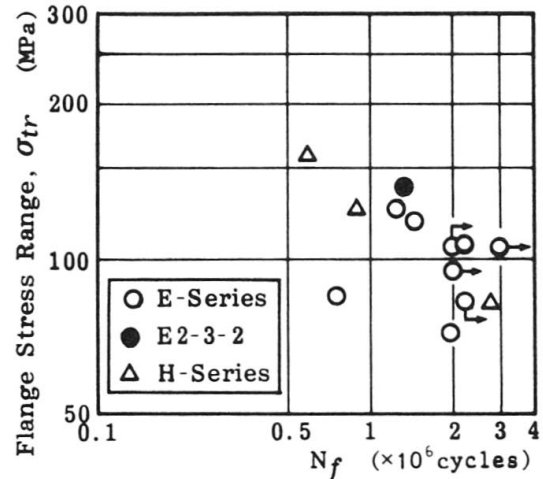
Fig. 3 S-N relations for beam specimens.

Fig. 3 shows S-N relationships expressed in terms of flexural stress ranges in the tension flange, σ_{tr} . The points vary widely and the fatigue strength at two million cycles is only about 80 MPa. These would have been caused by changes in material properties due to the welding heat, occurrence of weld residual stress, stress concentration due to the discontinuity of geometrical shape at the root of the stud, and so on. Judging from the above-mentioned conditions for the crack initiation, however, it can be known that the horizontal shear force which acted on the stud shear connector must be a more important influence factor for the fatigue life of the tension flange.

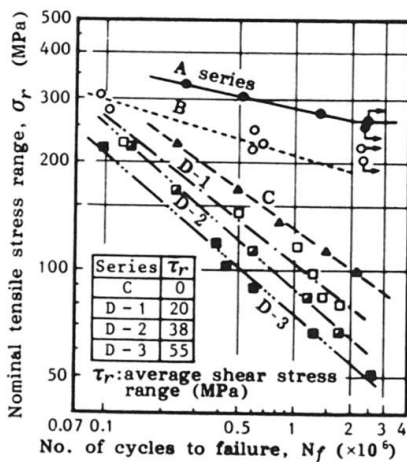
Fig. 6 S-N relations for SS41 steel.

Since the S-N relationships for the test series (A ~ D) show similar tendency for three kinds of steels (SS41, SM50A, SM58Q), the following discussions are mainly referred to the results for SS41 steel in Fig. 6.

The fatigue strength of B-series is lower about 70 MPa than that of A-series throughout the cycle lives. This reduction would have been primarily caused by the stress concentration due to internal weld defects such as blow-holes or lacks of fusion, because all of the fatigue cracks in B-series were initiated at the locations of these defects.

Besides, the fatigue strength of C-series reduced furthermore. In all of the specimens of C-series, a fatigue crack was initiated at either one of the upset edges closest to the ends of the plate, and propagated more rapidly toward the both sides of the plate, whereas no crack initiation was observed at internal weld defects as seen in B-series. Accordingly, it can be understood that the stress concentration due to the geometrical discontinuity at the toe of weld upset had a great influence on the fatigue strength of the plate.

The results of the fatigue tests for each steel are presented in the form of S-N diagrams in Figs. 6 ~ 8, on the basis of log-log relationship between the nominal applied tensile stress range in the plates, σ_r , and the number of cycles to failure, N_f .

By comparing four S-N curves of C, D-1, D-2 and D-3 series which are given in respective Figs. 6 ~ 8, it is evidently noticed that the fatigue strength of the plate at any cycle life reduces gradually as the shear stress range, τ_r , increases. When the correlation between tensile stress ranges at two million cycles and shear stress ranges was investigated, it was found out that the fatigue strength of the plate decreased nearly in proportion to an increase of the shear stress, and that its relation had little difference for the three steels.

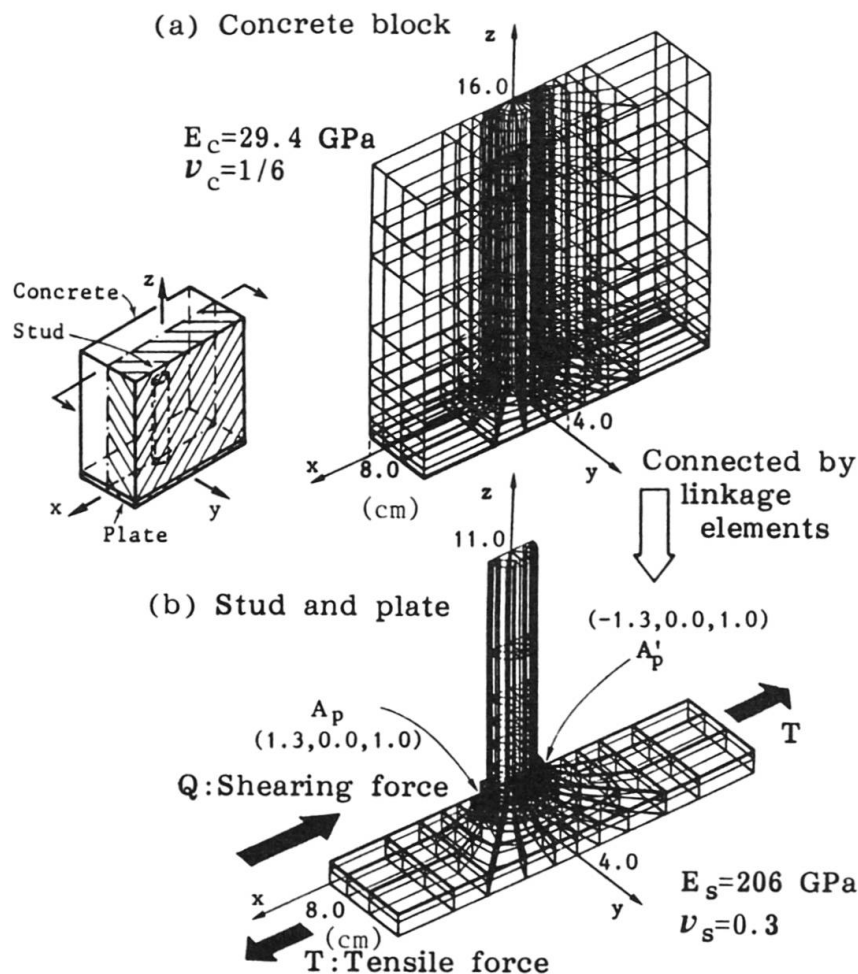
The steel part of a test specimen of D-series, namely a steel plate and a headed stud, was replaced by a model consisting of a flat plate and columns. The measurement showed that the shape and size of the actual weld upset were rather irregular, and its diameter, height and contact angle were approximately $1.3d$, $0.25d$ and $40^\circ < \theta < 140^\circ$, respectively. Here, d is a diameter of stud shank and θ is an angle between the side of the upset and the surface of the plate. The half model was divided, for its symmetry, into a mesh as shown in Fig. 10 by using linear elements such as triangular prism, quadrangular prism and rectangular brick, of which degree of freedom for deformation was three per a node. For a simple consideration of relative slips or separations between steel and concrete, linkage elements which have only spring stiffness and no volume, were used on the contact surface between steel and concrete to connect them. Though the angle θ had undoubtedly a large influence on the stress concentration, it was tentatively determined as 90° for laying emphasis on what stress condition occurs at the root rather than on what value is computed for the stress concentration factor, and besides for convenience of the element mesh division. Other models with different

Fig. 10 Finite element mesh division.

shape and size of the upset could not be analyzed because of enormous computer time. In Fig. 10(b), the point A_p or A_p' is a location where the largest stress concentration will occur as described later, and also is an intersection point between the edge of upset and z - x plane.
