Zeitschrift: **IABSE reports = Rapports AIPC = IVBH Berichte**

Band (Jahr): **46 (1983)**

## Non-linear Analysis and Strengthening of a Reinforced Concrete Building

Severe disorders appearing in a reinforced concrete framed building led to the necessity of determining its safety level. This aim was achieved both with experimental tests and with numerical analyses, linear and non-linear. Non-linear analysis proved to be very useful in determining the moment redistribution capability of the structure and realistic values of displacements.

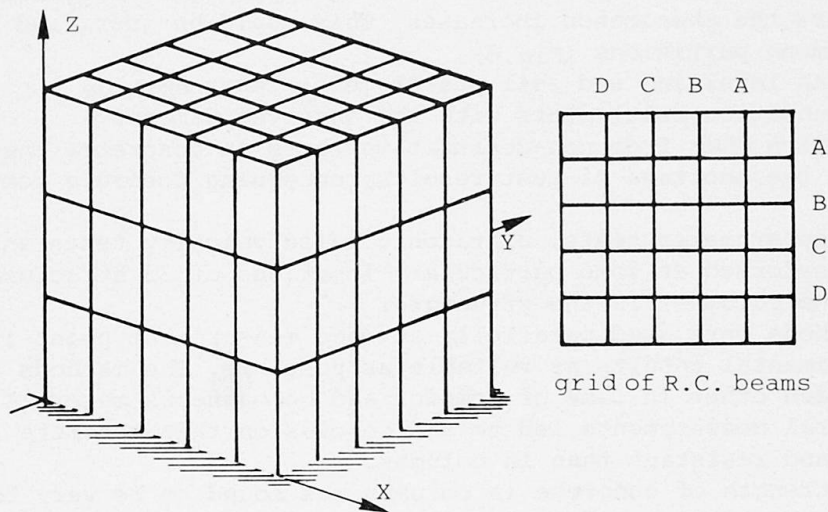
Fig.3 Simplified topology of the structure

The aforesaid considerations were applied to the case of a recently built r.c. building, where damages occurred due to excessive deflections (Figs.1 and 2). The building is schematically shown in Fig.3: it is composed of 3 floors, the ground floor being used as lecture-hall. The others were partitioned in order to be used as studies and laboratories.

The beams B and C of the grid (Fig.3) were supposed to belong to a multistory plane frame which was analyzed using both linear and non-linear analysis. In this way the influence of torsional stiffness of transversal beams on flexural moment distribution was disregarded.

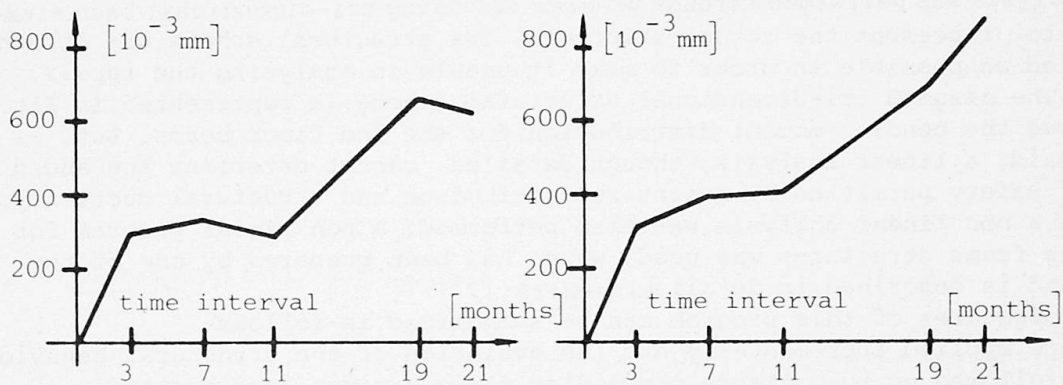
Fig.4 Gauge length variation across two cracks (versus time)

Few years after completion of the building large and increasing deflections of the beams were observed, which led to cracking in partitions (Fig.2). A group of 30 strain-gauge lengths were chosen across the cracks in partitions and the opening of cracks was measured and plotted versus time. Fig.4 shows some typical diagrams making clear the increasing trend of the deformation, if seasonal variations are suitably taken into account. The increase in damage led to the need of accurate experimental measurements and computational analyses in order to assess the safety conditions.

The mentioned strain-gauge measurements across cracks were carried on and showed two different trends. At some locations the opening of cracks seems to decrease, at others the phenomenon increases. This could be justified by stress redistribution among partitions (Fig.4).

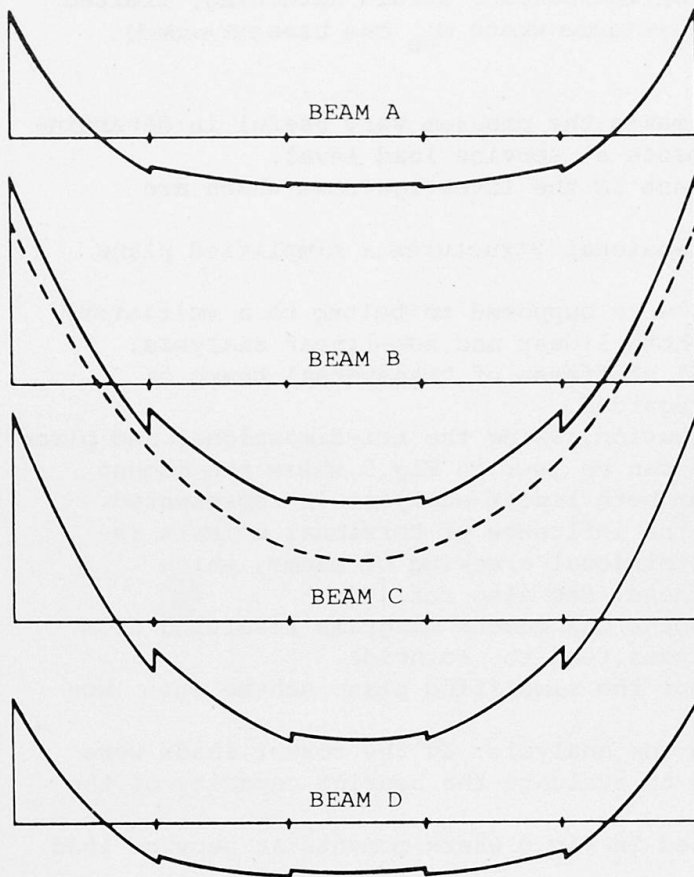
Fig.5 Tri-dimensional linear analysis: bending moments acting on 4 beams of 2nd floor grid

Linear analysis was performed through program SAP using tri-dimensional beam elements in order to represent the actual structure. The structural scheme was chosen as detailed as possible in order to make it usable in analyzing the repair effects. The assumed tri-dimensional structural scheme is represented in Fig. 3. Fig.5 shows the bending moment distribution for the 2nd floor beams. But, as already said, a linear analysis, though detailed, cannot determine the added margin of safety permitted by moment redistribution and structural ductility. Therefore a non linear analysis was also performed. A non linear program for r.c. plane frame structures was used, which has been prepared by one of the authors and is described in detail elsewhere |2||3|.

length — 1 m  
 moments — 100 kN.m  
 — 3-D linear analysis  
 - - - 2-D linear analysis

The differences in beam moment distribution, using the tri-dimensional and plane frame schemes are considerable, as it can be seen in Fig.5, where the moment distribution in beams deriving from both linear analyses is represented. However it must be kept in mind that the influence of torsional moments is greatly reduced by the flexural and torsional cracking of beams, which drastically lower the torsional stiffness. See also ref. |4|.

If this phenomenon is taken into account the moment diagrams resulting from tri-dimensional and plane linear analyses tend to coincide.
