# Ambient vibration effects on the Colosseum

Zeitschrift: **IABSE reports = Rapports AIPC = IVBH Berichte**

Band (Jahr): **70 (1993)**

## Ambient Vibration Effects on the Colosseum

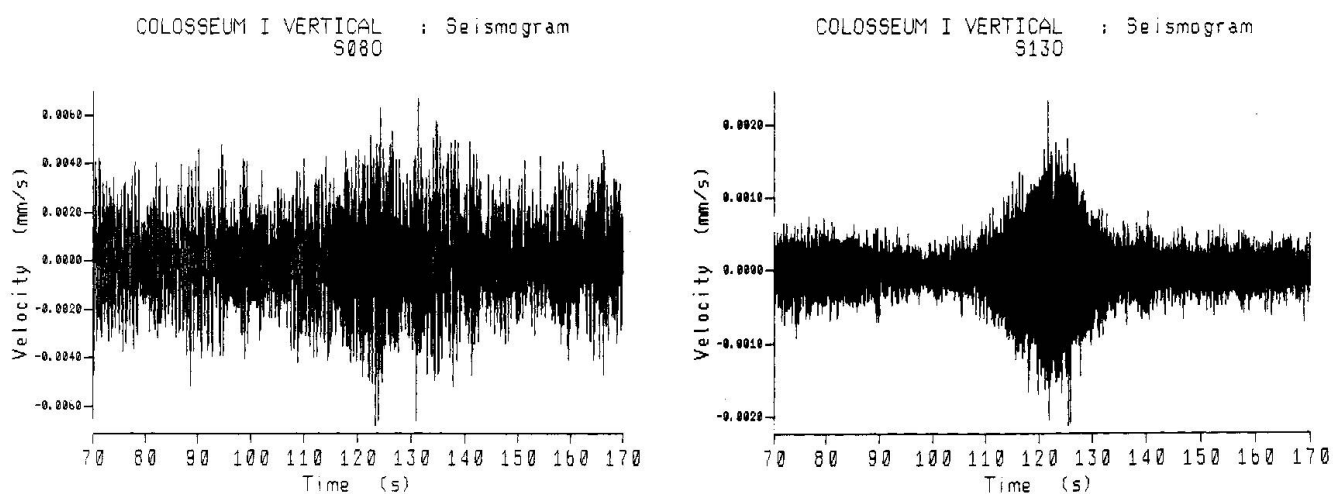
**Fig. 2** Seismograms at locations S13 and S8 obtained during the transit of the train of the underground

The transit of the train is apparent only at the S13 location at the basement, moreover there is amplification over the whole time range going from the basement to the top of the wall. The frequency domain analysis proves that there is no significant difference in the behaviour, with and without the transit of the train.

The time series have been analyzed for time intervals of 100 seconds, out of the 300 total, in order to discriminate any difference due to the transit of the train in the nearby underground. The records obtained during the transit of the train at the locations S13 and S8 are illustrated in figure 2.

The comparison with the maximum value at the basement of historical and archeological monuments suggested by the german code DIN 4150 (2-3 mm/sec) pointed out the limited effects of the traffic induced vibrations on the Colosseum. This result, in conjunction with the statements referring to the seismograms at locations S13 and S8, allow us to state that the traffic induced
