Structural Assessment of Lisbon's Historical Buildings

S. POMPEU SANTOS

Mary MUN

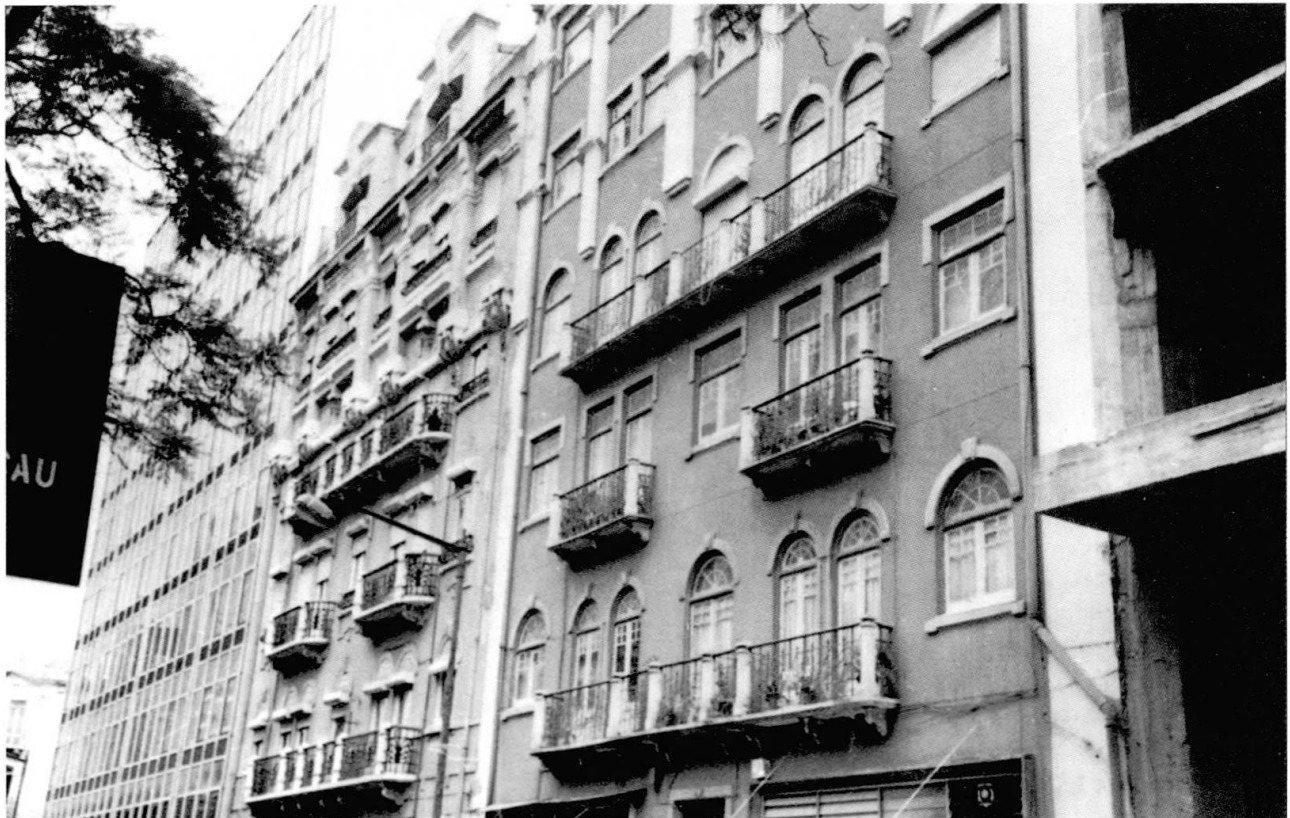
Fig. 1: Two surviving buildings in the Study Area

In the Study Area constructions dating from the late 19th - early 20th century (1880-1930) predominate. These constructions have a characteristic structural typology (termed "gaioleiro"), featuring:

- external walls of irregular stone and weak mortar, single or double leafed, the exterior leaf made of brick masonry;

- internal walls of solid or perforated bricks, with or without a wooden frame (lower floors), and light wood panelling (upper floors);
- wooden floors and staircases; wooden roof structures;
- small inner courtyard (central or lateral) for admission of light and ventilation, enclosed by single or double leafed masonry walls;
- balconies at the back of the building, with tile flooring supported by a light (metal) structural frame.

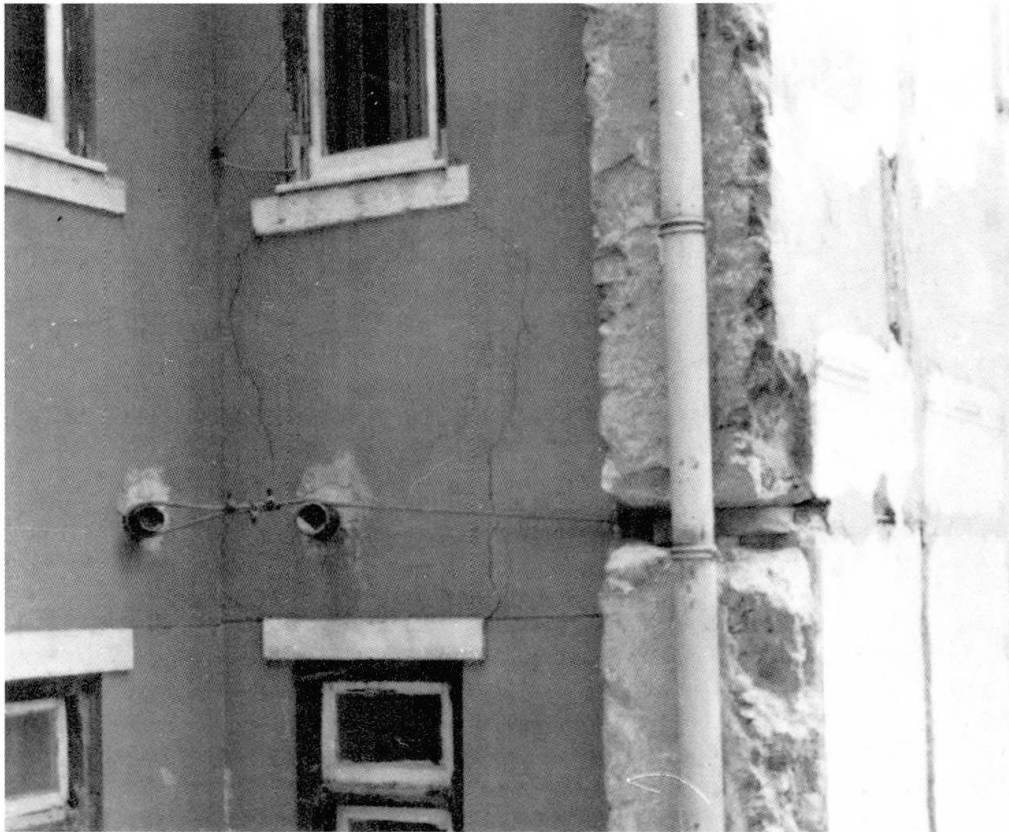
Fig. 2: Damaged masonry wall due to demolition of an adjoining building

- excavation works, both at the surface and underground, in the proximity of, or under existing buildings, resulting in localized differential settlements of the wall foundations;
- demolition of one of two buildings having a common separation wall, resulting in the destruction of the original connection between intersecting walls, both at the façade and at the back (Fig. 2);
- alterations to the existing structural system involving the total or partial demolition of load bearing walls (negative shoring-structure interaction);
- overloading through a change in building usage (eg. office archives in previous dwellings).
