Zeitschrift: IABSE reports = Rapports AIPC = IVBH Berichte
Band: 70 (1993)

Structural Assessment of Lisbon's Historical Buildings

S. POMPEU SANTOS

Mary MUN

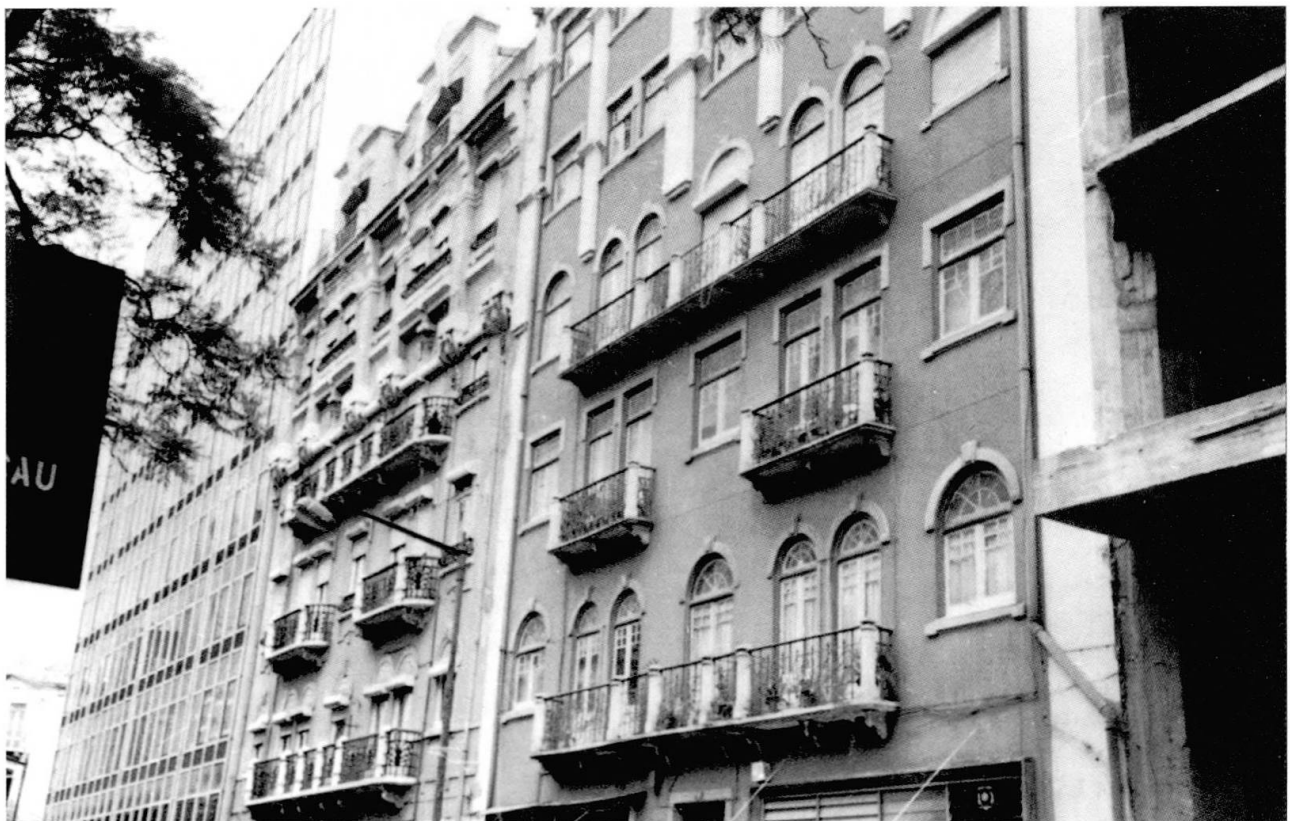
Fig. 1: Two surviving buildings in the Study Area

In the Study Area constructions dating from the late 19th - early 20th century (1880-1930) predominate. These constructions have a characteristic structural typology (termed "gaioleiro"), featuring:

- external walls of irregular stone and weak mortar, single or double leafed, the exterior leaf made of brick masonry;

- internal walls of solid or perforated bricks, with or without a wooden frame (lower floors), and light wood panelling (upper floors);
- wooden floors and staircases; wooden roof structures;
- small inner courtyard (central or lateral) for admission of light and ventilation, enclosed by single or double leafed masonry walls;
- balconies at the back of the building, with tile flooring supported by a light (metal) structural frame.

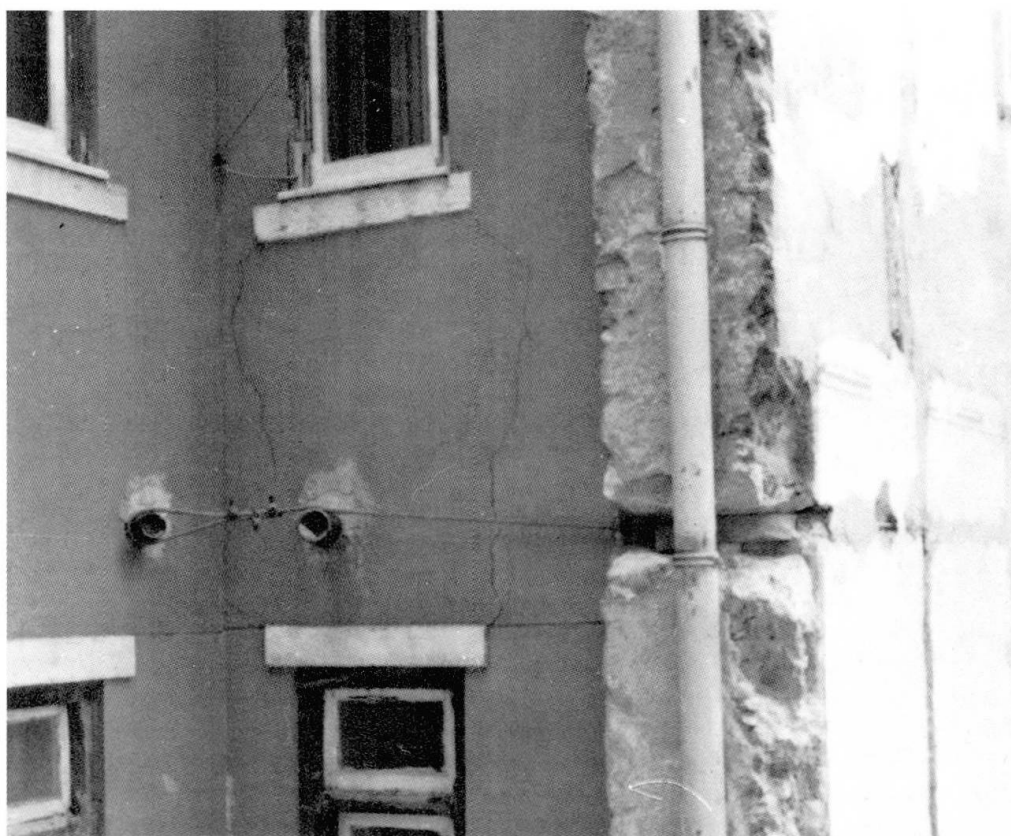
Fig. 2: Damaged masonry wall due to demolition of an adjoining building

- excavation works, both at the surface and underground, in the proximity of, or under existing buildings, resulting in localized differential settlements of the wall foundations;
- demolition of one of two buildings having a common separation wall, resulting in the destruction of the original connection between intersecting walls, both at the façade and at the back (Fig. 2);
- alterations to the existing structural system involving the total or partial demolition of load bearing walls (negative shoring-structure interaction);
- overloading through a change in building usage (eg. office archives in previous dwellings).
