Zeitschrift: IABSE reports = Rapports AIPC = IVBH Berichte
Band: 70 (1993)

Artikel: Consolidation of 'fill layer' masonry structures
Autor: Contini, Piero / Debernardi, Pier Giorgio
DOI: <https://doi.org/10.5169/seals-53341>

Consolidation of 'Fill Layer' Masonry Structures

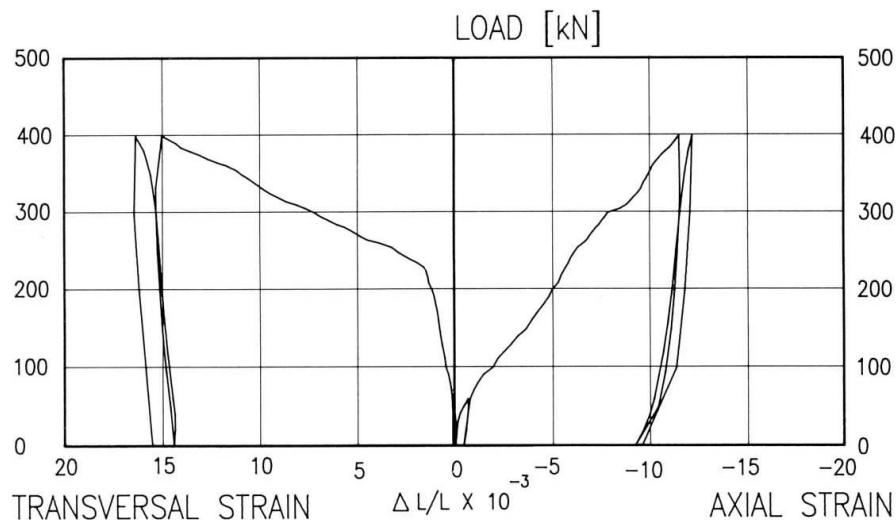
Fig. 6 Load-strain diagram, specimen No. 12

A load-strain diagram is shown in fig. 6. Transverse strains are shown on the left, and it can be seen that vertical cracks appeared at a load level of about 220 kN and then continued to increase in width with increasing load. It should be noted that at the maximum load reached at this stage (400 kN) the width of the main crack was about 3.75 mm: in actual practice, this corresponds to the specimen's maximum bearing capacity, as was also confirmed by the value of residual strain after the removal of the load. A subsequent loading cycle showed that the slope of the axial load-strain diagram, shown in the right-hand side of the diagrams in fig. 6, was greater than in undamaged specimens. This aspect must be taken into account when comparing the deformability of consolidated specimens.
