System reliability for condition evaluation of bridges

Zeitschrift: **IABSE reports = Rapports AIPC = IVBH Berichte**

Band (Jahr): **76 (1997)**

System Reliability for Condition Evaluation of Bridges

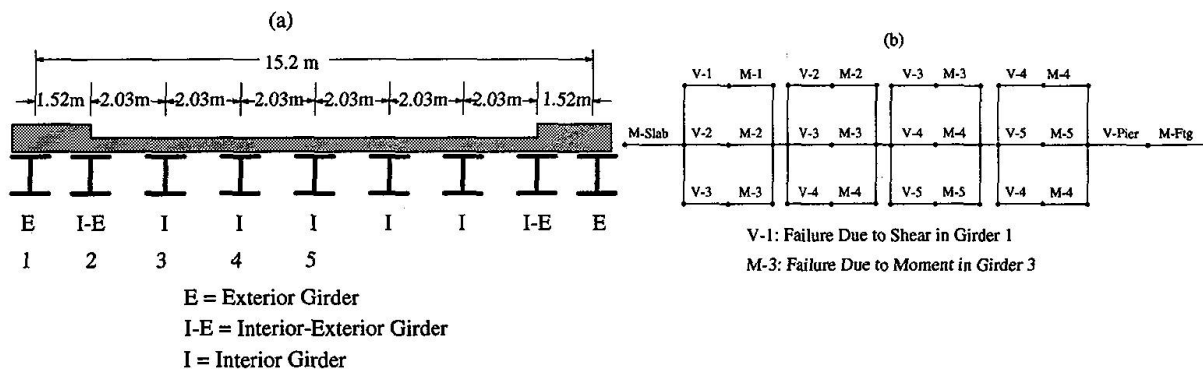
A time-dependent system reliability approach is applied to optimize the repair strategy for an existing highway bridge (Colorado State Highway Bridge E-17-AH). The bridge is on State Highway 33 in Denver, Colorado, and has three 13.36 m simply-supported steel-concrete composite spans. The 12.18 m wide roadway carries four lanes of traffic with an Average Daily Traffic (ADT) of 8500 vehicles. The deck is reinforced concrete and the steel girders are standard rolled shapes with simple-span supports. The interior span supports are reinforced concrete pier columns with a pier cap, four supporting square tapered columns, and individual column footings. The concrete abutments are supported by concrete piles cased in steel. A local railroad spur runs underneath the bridge. The cross section of the superstructure is shown in Fig.1(a) where the girders are classified as exterior (E), interior-exterior (I-E), and interior (I).

Fig. 1 Colorado State Highway Bridge E-17-AH: (a) Designation of girders, and (b) Simplified series-parallel model

Using 24 separate random variables, the intact bridge was analyzed with respect to 16 different failure modes including moment failure of the slab, moment and shear failure of the girders, and multiple failure modes of the pier cap, columns and footings. Limit state equations were developed and the reliability of each component was computed separately. The bridge system was modeled as a series-parallel model. Both the component reliabilities and the system reliability of the bridge were computed. A simplified system model for the bridge where it is assumed that the superstructure will not fail until three adjacent girders have failed is shown in Fig. 1(b). The simplifying assumptions, a more refined model, and a complete description of these calculations are given in Estes [5].

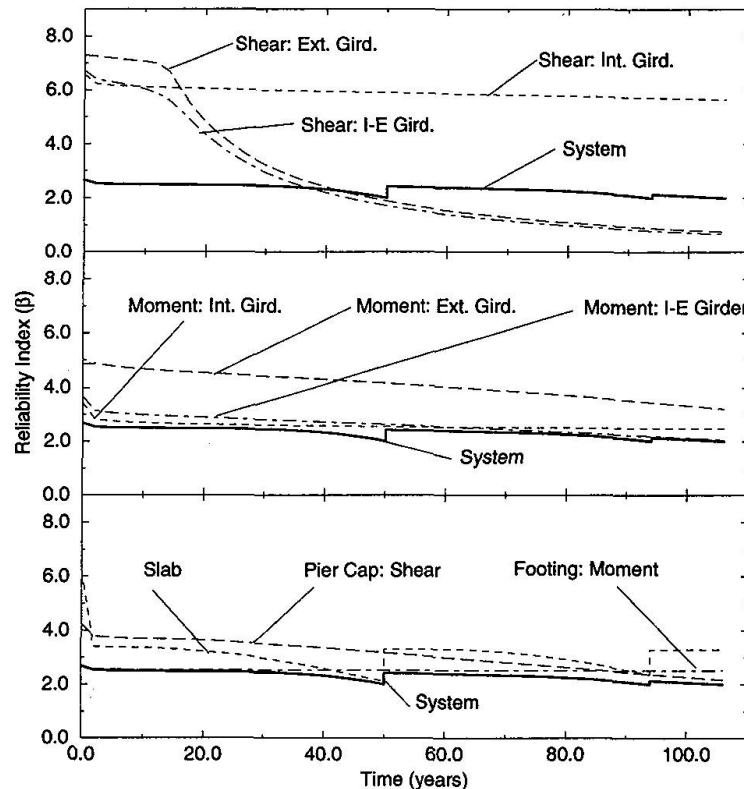
For option 1 (replace deck), Fig.2 shows the time-dependent reliabilities of the bridge system and of all components shown in Fig. 1(b). The deck is replaced when $\beta_{system} \leq 2.0$. Consequently, the deck is replaced twice at years 50 and 94 of the bridge life. At year 106, a deck replacement is not sufficient to improve β_{system} to a value larger than 2.0. Due to the parallel nature of the system, the reliability of some components are allowed to fall below $\beta_{T,system\ life} = 2.0$. Due to varying deterioration rates, the critical component early in the life of the structure is not necessarily the most important later on.

Fig. 2 Results of repair option 1: Replace deck on Bridge E-17-AH using series-parallel system model requiring the failure of three adjacent girders

Using the results of NDE inspections, the reliability of the girders, the deck, and ultimately the system are updated. Using the same repair options listed earlier, Fig. 6 shows the results of Option 1: Replace the Deck. Fig. 6 can be compared to Fig. 2 which showed the time-dependent reliability of the bridge components and bridge system when the deck was replaced twice using the original deterioration models. Despite the updated inspection results, the figures are quite similar, except for the reliabilities with respect to girder shear. The girder reliabilities with respect to moment are close to the original model. The moment capacity is dependent on the plastic section modulus which is less sensitive to the small changes in the thickness loss. In Fig. 6, the slab is replaced at year 52 and year 98, and at year 108, a slab repair is no longer sufficient to raise the system reliability above $\beta_{min}=2.0$.

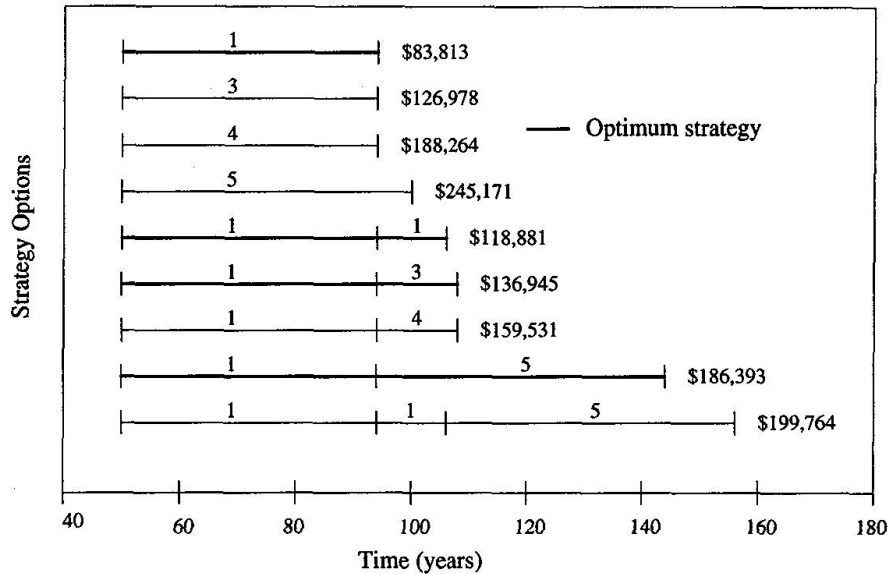
Let's assume the bridge is placed in service in 1996. Accounting for all combinations of options and using an assumed discount rate of 2%, the possible repair strategies and their associated present value costs are shown in Fig. 3. The analysis continued until replacement of the bridge (i.e., option 5) becomes the only available solution. From Fig. 3, the optimum strategy can be determined for the expected life of the bridge. For example, for a life of 50 years, no action should be taken; for 50-94 years, replace the deck at year 50 (\$83,813); 94-106 years, replace the deck at year 50 and year 94 (\$118,881); 106-108 years, replace the slab at year 50 then replace the exterior two girders and slab at year 94 (\$136,945); and after 108 years, replace the slab at year 50 then replace the bridge at year 94 (\$186,393).

Fig. 3 Strategy options and associated costs

With regard to the reliability of the system, the girder reliabilities do not dominate the system. The reduced girder corrosion rate uncertainty improves the reliability of the individual girders, but has little to no effect on the system. The slab, which is deteriorating more rapidly than the other critical failure modes, eventually dominates the reliability of the system. The effects of longer chloride initiation time T_I and increased uncertainty in the corrosion rate r_{corr} offset each other. As a result, the minimum system reliability $\beta_{min} = 2.0$ is violated after 52 years of service, which is very close to the 50 years of service in the earlier model. Again, accounting for all relevant repair possibilities and using a discount rate of 2%, Fig. 7 shows all feasible strategy options and their associated costs which can be compared to Fig. 3 using the original model.

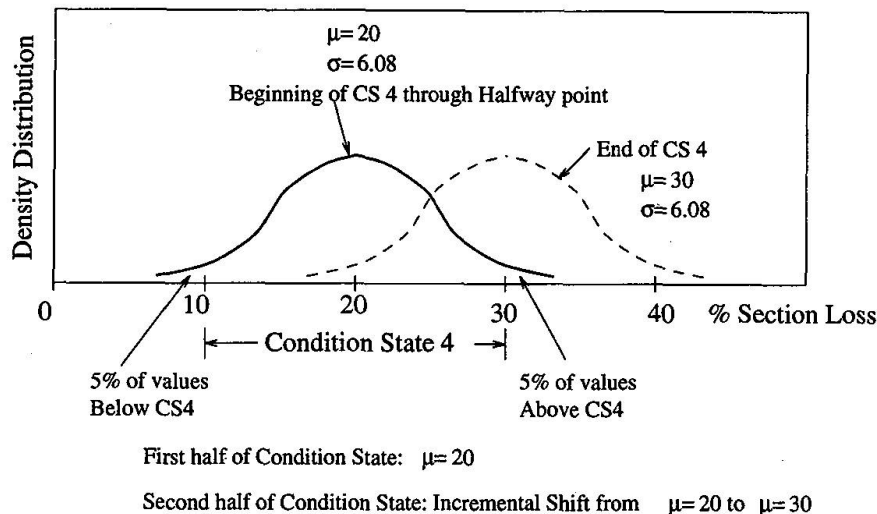
The parameters of random variables cannot be obtained directly from a visual inspection. Some assumptions must be made regarding the accuracy of the results and quality of the information provided by the inspectors. This study assumes that condition state deterioration over time is linear and that the deterioration intensity is normally distributed. It is further assumed that when a bridge element is at the halfway point of a specific condition state, the mean value of the normal distribution is at the halfway point of the condition state definition (see Fig. 4).

Fig. 4 Density distribution of deterioration for Element 107 in Condition State 4 when inspectors are correct 90% of the time.

The standard deviation is determined by the assumed quality of the inspection program. If the inspector is believed to be correct 90% of the time when the member is at the halfway point of the condition state, then 90% of the values in the normal distribution will be within the values prescribed by the condition state. To make this assumption conservative, the condition state is assumed to begin at the halfway point and shifts progressively to the right as shown in Fig. 4. If the element remains in the condition state longer than expected, the distribution will remain at the far right position until an inspection reveals a switch to the next condition state. The exception will be for the first and final condition states where a lognormal distribution is used.

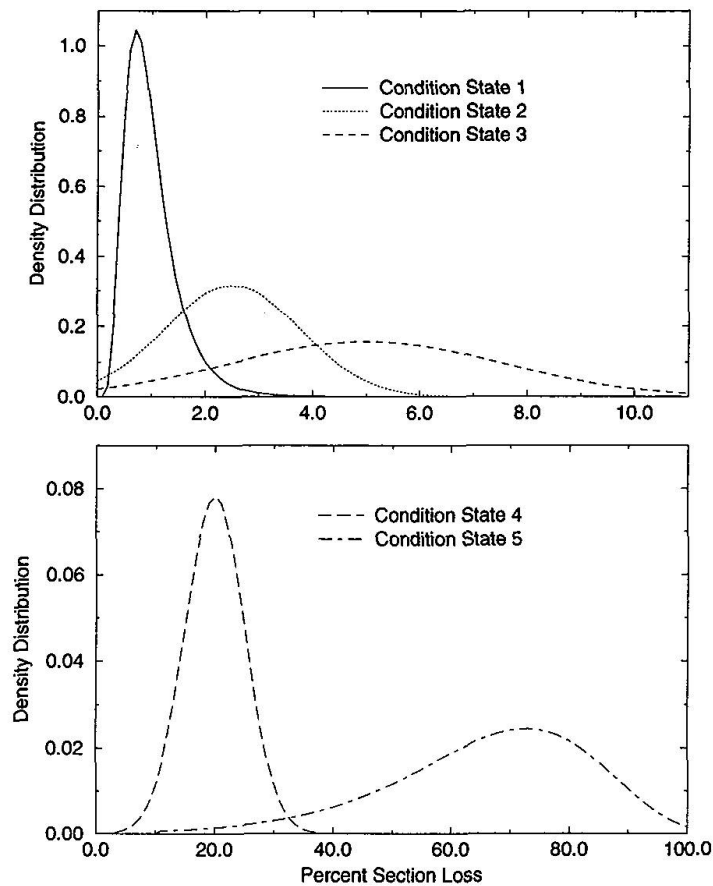
Fig. 5 Density distributions associated with Condition State (CS) ratings CS1-CS5 for Element 107: painted open steel girders, Inspection Category A

This study considered three different qualities of inspection programs, A, B, and C, where the inspectors were provided the correct rating 95%, 85%, and 75% of the time, respectively. The quality of the inspection program was determined based on seven criteria [5] which included inspector training, a quality assurance program, and inspector experience. The density distributions associated with condition states 1 through 5 for Inspection Category A and Element 107 as listed in Table 1 are shown in Fig. 5. Condition states 1, 2, and 3 were modified to reflect section losses of 0-2%, 0-5%, and 0-10%, respectively. Once the parameters of the random variables which describe the percent section loss for the corroding steel girders are defined, the area of the web and the plastic section modulus at the time of inspection can be computed. With the revised shear and moment capacities of the girders, the updated reliability of the bridge girders is computed. Assuming linear condition state deterioration over time, the future performance of the structure is predicted.

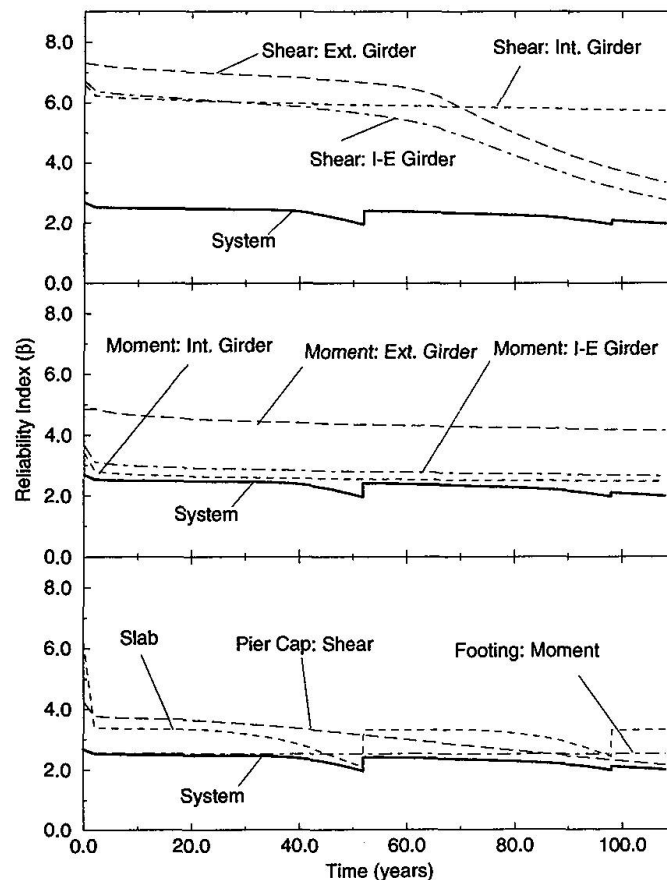
Fig. 6 Updated results of repair option 1 on Bridge E-17-AH using simplified series-parallel model requiring the failure of three adjacent girders

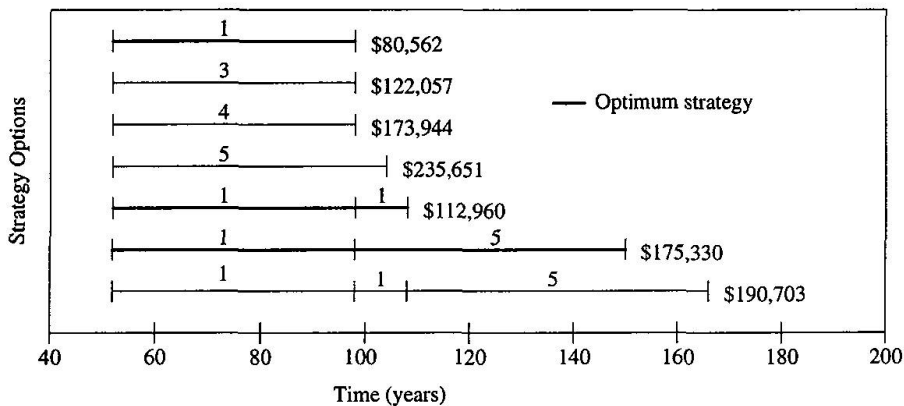
Fig. 7 Updated strategy options and costs (2% discount rate) for Bridge E-17-AH using simplified series-parallel model requiring the failure of three adjacent girders

As a result, the updated optimum strategy is as follows: for a life of 52 years, no action should be taken; for 52-98 years, replace the deck at year 52 (\$80,562); 98-108 years, replace the deck at year 52 and replace the deck again at year 98 (\$112,960); and after 108 years, replace the slab at year 52 and replace the bridge at year 108 (\$175,330). Updated inspection results would not always produce such minor changes in strategy. The lack of change in this update is due to the compensating differences in the deck results where the positive effect of an increased chloride initiation time was offset by a more uncertain corrosion rate. If the slab had been deteriorating more slowly and the girders more rapidly than the model suggested, then the updated lifetime bridge repair strategy would have been quite different.
