Artikel: Inspection of bridges with orthotropic steel decks with particular attention to fatigue
Autor: Leendertz, J.S. / Weijde, Henk v.d. / Kolstein, Henk
DOI: <https://doi.org/10.5169/seals-57460>

Inspection of Bridges with Orthotropic Steel Decks with Particular Attention to Fatigue

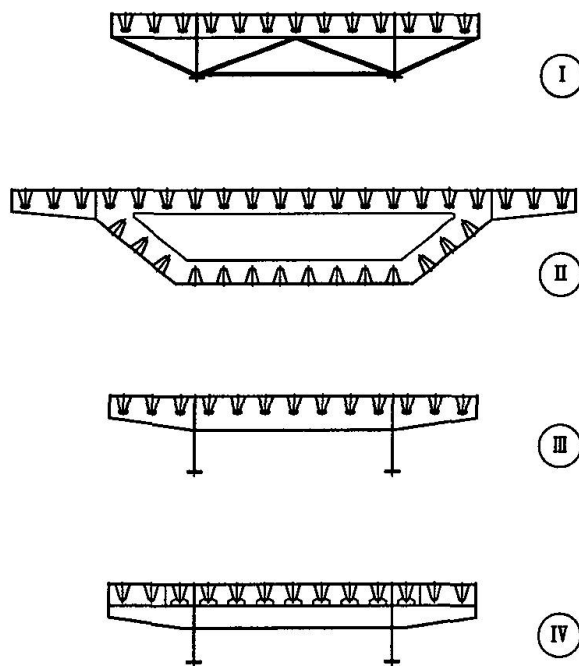
Fig. 4 Structural types of bridges

Fig.4 shows four load carrying systems. For simplicity only systems with continuous closed stiffeners are shown. Type I is a plate girder bridge with crossbeams that consists of a truss and a top cord acting as a continuous beam with short spans. The continuous beam transfers the loads by bending and shear to the truss nodes. The truss is supported by the main girders. Type II is a box girder bridge. The diaphragm of the box acts as a deep crossbeam that transfers the loads to the inclined and vertical webs of the box girder. Type III is a conventional crossbeam with cantilevers that are supported by the main girders. Type IV is an I-shaped crossbeam that receives the loads from the supports of the closed stiffeners. The shear connections in the cantilever sections cause a rotational spring using the axial stiffnesses of the deck plate and the I-beam and a lever arm. This is called the "Floating Deck Structure" and is used in a few bridges in the Netherlands [1]. It has been developed for its easy of assembly.

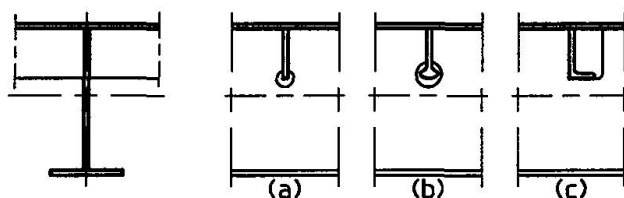
Fig. 5 Crossbeam connections with continuous open stiffeners

type (a) and (b) it causes a local stress concentration, but in Fig.5 type (c) a "Vierendeel" effect with additional bending is to be expected. This effect will be explained later in conjunction with the closed stiffener connections.

Because the influence lines show short distances between the zero-crossings a rather unfavourable connection is submitted to many cycles caused by the wheel loads. Fig.5 shows the connections of continuous open stiffeners to the crossbeams. In the connections shown, cope holes have been used for fitting purposes. The cope hole causes a discontinuity in the crossbeam. In Fig.5

In two plate girder bridges with open stiffeners and truss diaphragms cracks have been found in the stiffener to crossbeam connections [11]. Here the bulb stiffeners pass through circular cut outs as shown in Fig.5(b).

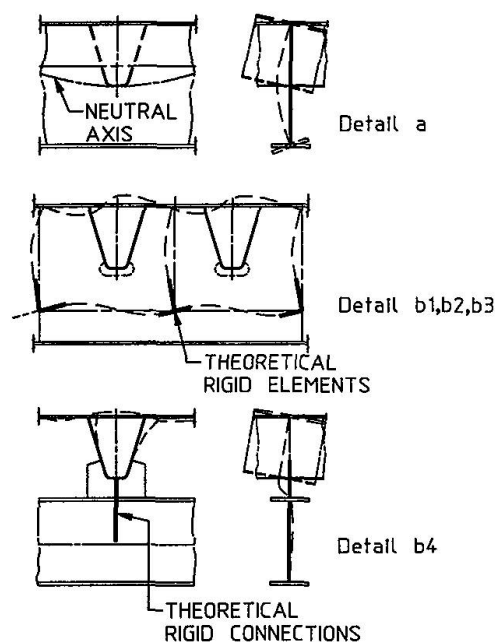
Fig. 6 Closed stiffener connections and structural behaviour

Fig.6 shows both the connections and their structural behaviour. Two groups are distinguished:

- a. Troughs fitted between the crossbeams
- b. Continuous troughs passing through cut outs with cope holes

Usually Group "a" connections are applied in structures with shallow crossbeams, where cut outs cause a too low shear capacity of the crossbeam. In the past, the detail with fillet welds showed many fatigue cracks. The details with full penetration welds show a much better fatigue performance.

The Group "b" connections are applied in structures with deeper crossbeams, diaphragms of Box Girder Bridges, "Floating Deck" structures. The following subdivision can be made:

- "b1": Continuous troughs passing through a cut out with close fit and welded around with fillet welds;
- "b2": Continuous trough passing through a cut out with an oval shape or similar;
- "b3": Continuous trough passing through a cut out with additional cope holes with varying radius, the so-called "Haibach cut out" [4] or a similar shape;
- "b4": Continuous trough supported by a counter-fitted support plate, welded around the bottom of the trough. Further the support is welded to an I-beam.

In plane, the cut out causes a "Vierendeel Effect" if the depth of the cut out is substantially, compared to the depth of the crossbeam or diaphragm [5,6,7]. This is likely to occur if the detail is applied in Crossbeams Type I and III bridge structures (see Fig.6). Further all details are subjected to locally applied forces and a contraction effect of the bottom of the stiffener caused by bending moments at the stiffener supports [8].

Passing vehicles generate bending and shear in the stiffeners, which deflect subsequently and makes the supports of the stiffeners rotate (see Fig.6). The rotation of this connection causes an out of plane movement of the crossbeam web. This phenomenon takes place in all types of stiffeners. The connection "b2" has been investigated in ECSC research Phase 3 and 4. In [2,3] the fatigue behaviour has been reported for various types of stiffeners and cut outs. The fatigue strength of details "b2" has been investigated under simultaneous vertical forces with out of plane bending in the web plate. Fig.12 shows for three test specimens the stress results of FE analyses under equal vertical load and out of plane rotation.

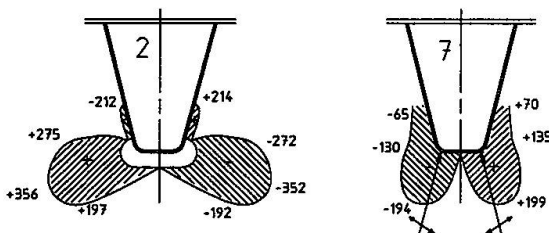
Fig. 8 Principal stress distributions around cut out and continuous weld (N/mm^2)

Fig.8 shows the results of FE-analyses with for a test specimen [3,7,9] the principal stresses around the cut out for crossbeam to trough nr. 2 (detail "b2") connection and a fully welded around crossbeam to trough nr. 7 (detail "b1") connection under the same but symmetrical bending and shear loads. The model consists of shell elements, which ignores the effect of the plate and weld dimensions in the neighbourhood of the welds. The arrows show the direction of the principal stresses at a specific location. Near to the welds the stress levels reach approximately the same level, but the direction with respect to the weld is completely different. Fatigue tests on a true scale specimen [3] showed a better performance for the connection of trough nr.7.

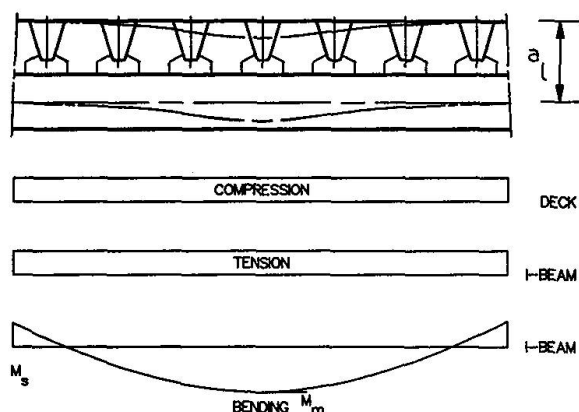
In the "Floating Deck" structure as shown in Fig.9 [1,10], the end of the I-beam is restrained by the lever system, which generates a compression in the deck and a tension in the I-beam. The horizontal compression and tension forces at a distance a_1 are balancing the bending moment M_s at the support. The normal forces in the deck and the I-beam, the rotations in the I-beam and the shear deformation in the I-beam cause the deck shifting over a distance S_h with respect to the I-beam as shown in Fig.10. Asymmetrical loads cause in some locations larger shifts S_h [10].

The shift S_h generates normal forces and bending moments in the trough web. Fig.11 shows the nominal stresses in the trough web and the deckplate caused by the shift S_h of 1mm. The shifts S_h for a set of beams of with depths are shown in [10]. Realistic values of S_h under maximum crossbeam loading vary from 0.1 - 3.3 mm. In real structures these stresses must be multiplied with a stress concentration factor in order to find the Hot Spot Stresses which are relevant for fatigue.

Fig. 9 Model of floating deck crossbeam

Fig. 10 Horizontal shift S_h Fig. 11 Stresses at a shift S_h of 1 mm (N/mm^2)

It is obvious that these stresses which mainly are governed by bending effects in the deck plate and trough web, can not be neglected. The stress concentration factors related to the bottom connection are assumed to be higher than the stress concentration factors related to the trough to deck connection. If however the stresses due to the wheel loading on the deck are added, high stress amplitudes may occur due to the combination of both effects.

In two bridges with the "Floating Deck" structure [1,9] some cracks were found in the longitudinal trough to deck weld (location 3) in the crossbeam neighbourhood of the crossbeam during a resurfacing operation [11]. Fig. 18 shows the relevant locations for fatigue which relate to the stresses in Fig 11. In the inspected bridges the deck plate had a thickness of 10 mm. No other cracks were found. The lack of time and the obtained insight in the mechanism led to the decision that the crack and the original weld were ground and replaced by a weld of 80% penetration, which had to be made in an overhead position. During repair the bridge was closed for all traffic.

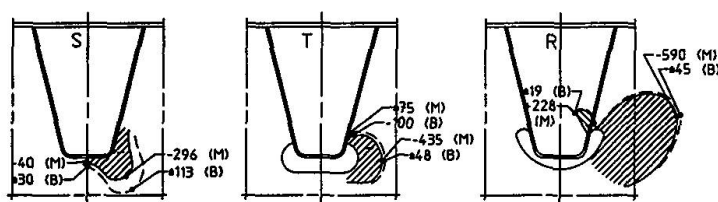
Fig. 12 Stress distributions under vertical load in combination with out of plane bending (N/mm^2)

The stresses shown are the membrane stresses (M) and the out of plane bending stresses (B) for test specimens at the Stevin Laboratory (NL) as reported in [2]. The models consisted of shell elements, which means that the stresses in the neighbourhood of the trough to crossbeam connection do not include the weld and plate dimension effects [9]. Nevertheless it is obvious that in this case, the rigid support not far below the trough to crossbeam web connection causes in the detail "b1" (S) much higher bending stresses than in the details "b2" (T) and "b3" (R). The types "b1", "b2" and "b3" refer to the detail categories of Section 4.2. The tests in the Stevin laboratory showed a better fatigue strength for the type "S", if compared to the types "T" and "R". The V-shaped stiffener connection tested at TRL (UK) however showed a lower fatigue strength. The results have been reported in [2].

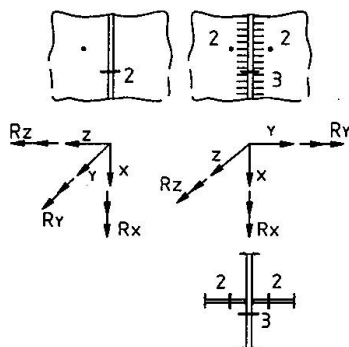
As a simplification, most of the details used in real structures can be reduced to 2 types of welded details, those with and without cope holes, see Groups "a" and "b" in Section 4.2. The combination of relevant degrees of freedom and the critical locations can be derived from the mechanical behaviour. Fig.13 and Fig.14 show the relevant degrees of freedom and critical fatigue locations for details without and with cope holes, Groups "a" and "b", respectively. Particular attention must be paid to the relevant influence lines and the stress concentration factors related to a degree of freedom and stresses in a specific location.

Fig. 13 Fatigue locations and degrees of freedom detail "a"

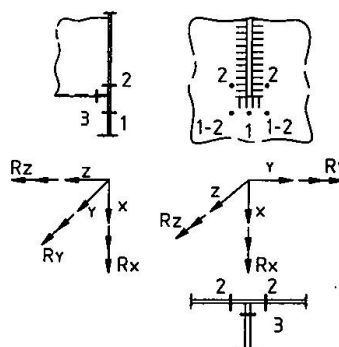
Fig. 14 Fatigue locations and degrees of freedom detail "b"

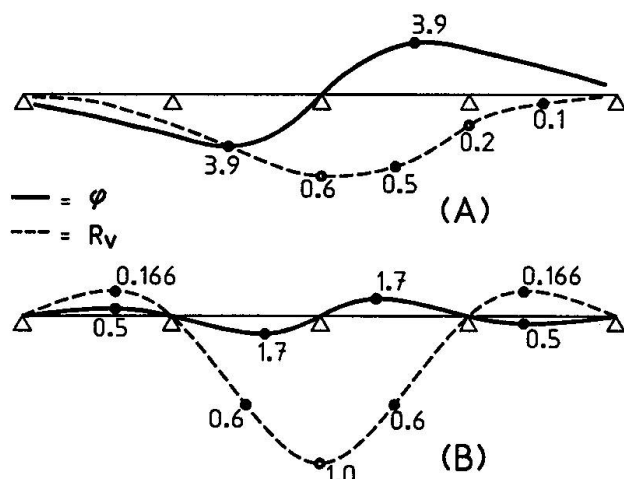
Fig. 15 Influence lines for stiffer support rotations (ϕ) and reactions (R_v)

Fig.15 shows the influence lines for rotations (ϕ) and crossbeam loading (R_v) of the middle trough stiffener support due to wheel loads. Lines (A) show the results for more flexible crossbeams and a (B) for more rigid crossbeams. Rigid crossbeams show higher loading than flexible crossbeams, but the amount of cycles under unit loads is higher. This effect applies as well for vehicle loads.

Flexible crossbeams show larger rotations, but a smaller amount of cycles than rigid crossbeams. It may be expected that in many cases open stiffeners will tend to have an influence line of type (B) which applies for closed stiffeners in box girder bridges too.

Closed stiffeners near crossbeam mid-span in plate girder bridges will act according a line between (A) and (B), depending on the vertical stiffness of the crossbeam. Near the supports they will tend to behave like (B).

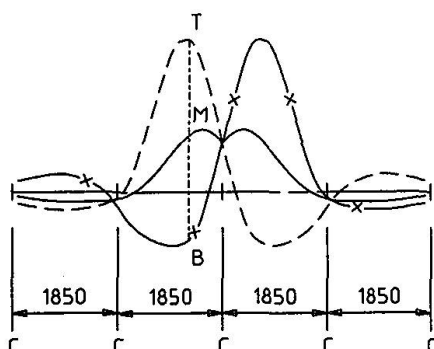
Fig. 16 Influence line stresses outer side web plate location "P"

Fig.16 shows for a 1kN wheel load the influence lines for the stresses in location "P".

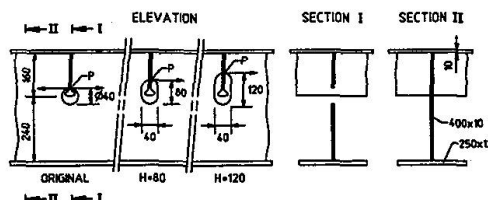
Fig. 17 Original detail and investigated cope holes and stresses for location "P"

Fig.17 shows the investigated details and stress locations. The out of plane bending of the crossbeam web showed to be of large importance. Two alternative cut outs with a larger depth have been investigated. The H=80 cut out has been selected as solution for the repair, because it showed a reduction of the stress amplitudes to 78% and proved to have the required shear capacity.

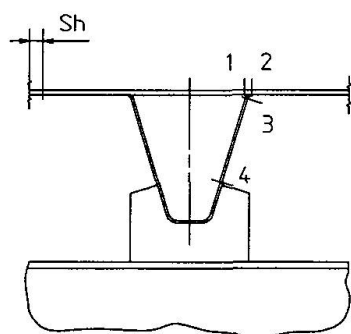
Fig. 18 Relevant locations for fatigue
