# BRIENZ ROTHORN BAHN

A Swiss Heritage Railway goes searching for old skills

Michael Ellis

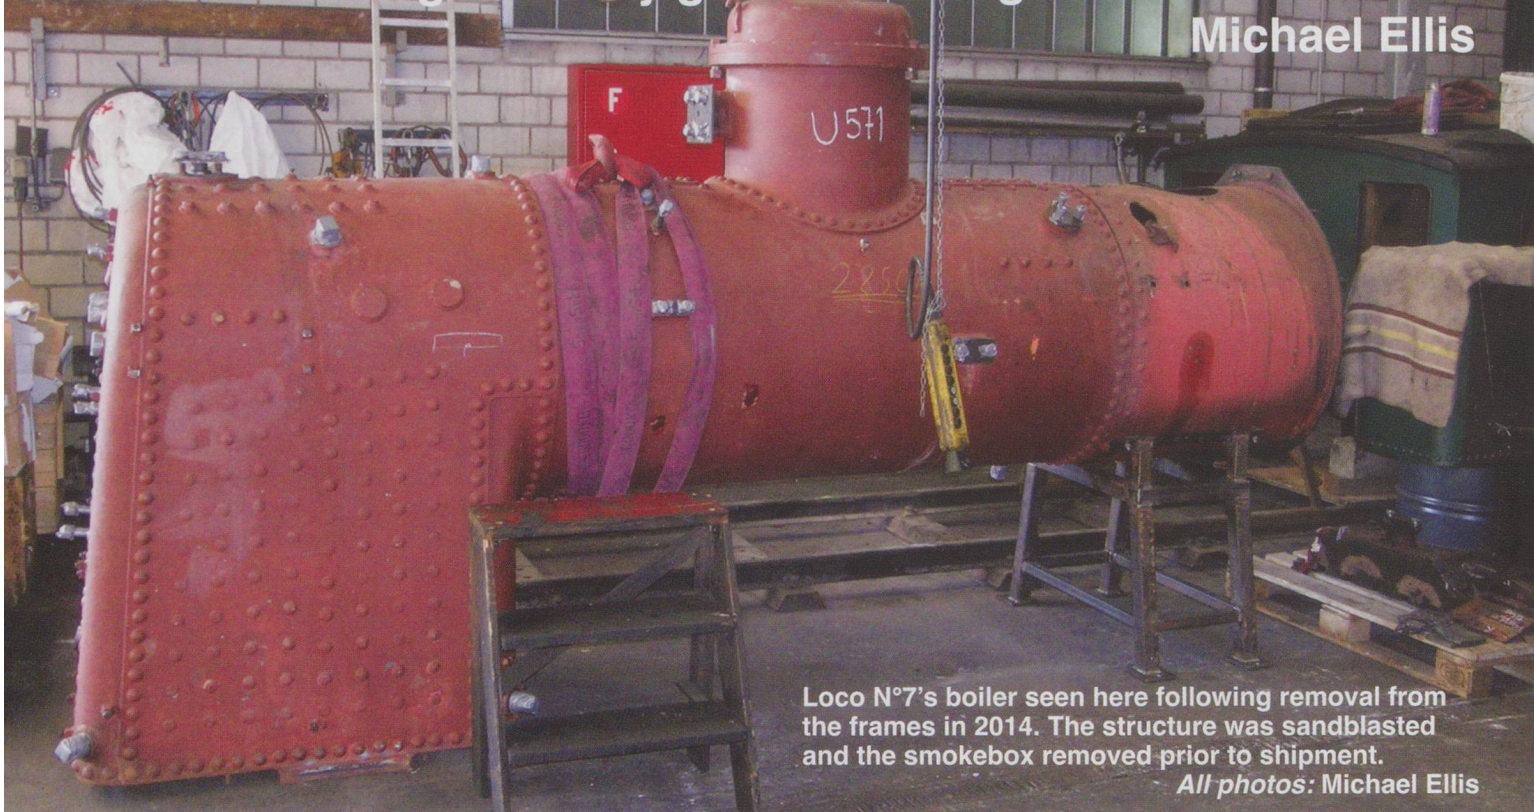
Loco N°7's boiler seen here following removal from the frames in 2014. The structure was sandblasted and the smokebox removed prior to shipment.

For the technically minded the work was to include: removal of the 'new' welded firebox installed in the 70's; removal and replacement of all boiler tubes; replacement of the steam pipe; renovation of the foundation ring; replacement of the inner firebox with a new copper (riveted) firebox as per original design circa 1932; new front tube plate and sundry other work. All in all a major rebuild to an old component. Would the Swiss Inspector, accept the plan? Richard and Steven were maybe a little too confident. Daniel and Mike were maybe a little too nervous and one poor translation between the English and Swiss German could screw it all up... Towards the end of the meeting Herr Kehrli, the Inspector, turned to me as the meeting translator. He clarified: We wanted to take an 85 year old boiler to England, dismantle it, replace and rebuild 60% of the construction, and, that with riveted not welded joints! And, to a design from 1932...? Were we serious? As calmly as I could, I said

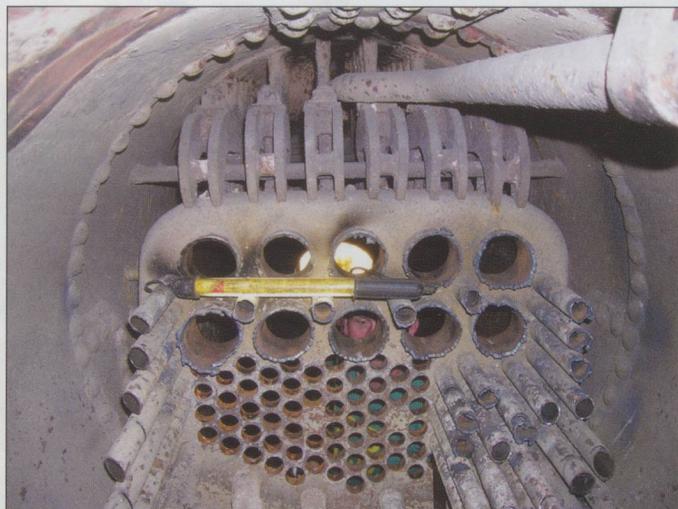
**TOP:** A great view taken inside the boiler. Here we see that the tubes have been cut away leaving only the ends to remove. The inner firebox construction (not original) is held in position at the top by the anchor brackets which allow for expansion movement. The steam pipe mentioned in the main text is the tube positioned top right. This connects the steam cavity in the dome to the regulator.

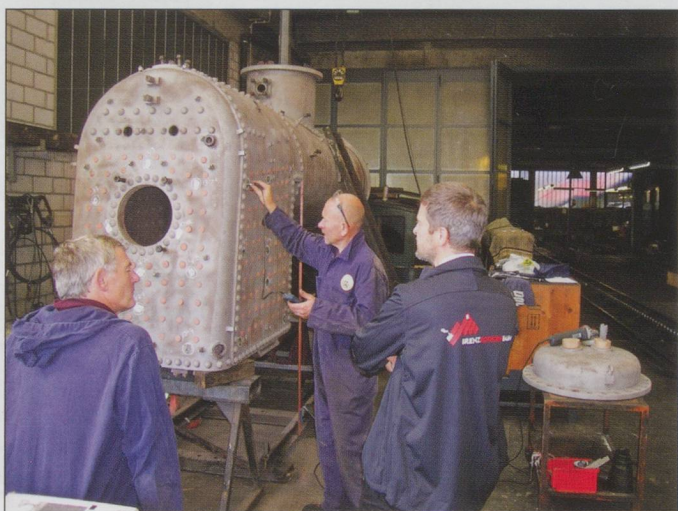
**MIDDLE:** Steven Latham from L&NWRH is seen here conducting the ultra sonic measurement of the outer firebox wall thickness. In places 85 years use had resulted in 0.7 mm erosion of 13 mm thick steel plate, still well within acceptable limits. L – R Richard Watkins, Steven Latham, Mike Ellis.

L&NWRH despatched Works Manager Steven Latham and Richard Watkins, his 'encyclopaedic' Boilersmith, to Brienz. The visit enabled them to undertake ultrasound tests and initially assess the boiler in order to advise us of what hidden horrors existed beneath the surface. This visit concluded with a meeting to which the Swiss Boiler Inspector was also invited, as his OK to the project was paramount.

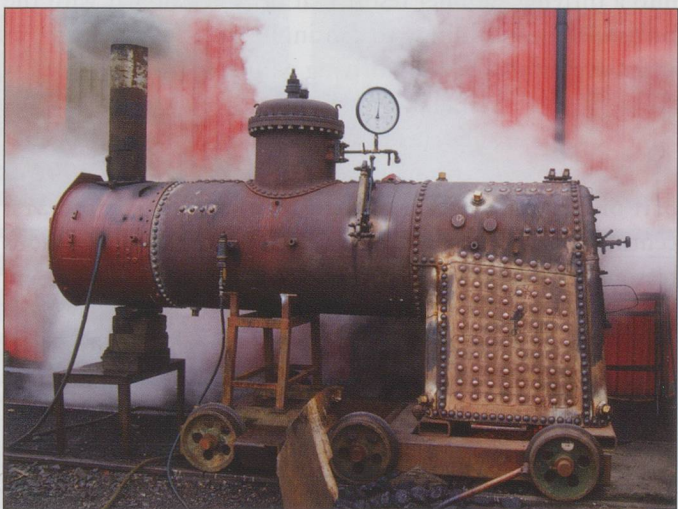
**BOTTOM:** Looking like an artefact from the next Mad Max movie the boiler of N°7 reaches test pressure. The lighter platework clearly shows the outer work undertaken by L&NWRH.

The plan is to have Loco No.7 back in traffic during 2016. It's a tight schedule and was dependant upon the boiler returning by February 2016. L&NWRH responded in style and during the Christmas period brought the work to a close. The cold hydraulic test was made and passed on the 18th January and on the 21st the BRB team returned to Crewe to witness the steam test. With the boiler held to the smokebox with two temporary bolts, and the whole sitting on an old trolley, it only required 4 of old GWR signal post to serve as a chimney and get a good fire going. Three hours later the first valve lifted and the job was done! From the perspective of one involved in the centre of all communications and decisions between Brienz and Crewe, it has been a well-delivered contract. It looks as though we will be on budget, on time and with a quality of work that reflects the immense amount of experience and engagement that the team at L&NWRH brought to the project. The documented project and experience gained will also enable the BRB to provide future consulting support to other similar projects within Switzerland, whilst future BRB projects are already planned. My personal thanks go to all concerned, whether mentioned or not, for assistance during the project and for information used in this article. For further information on the project email [Michael.ellis@brb.ch](mailto:Michael.ellis@brb.ch)
